## **SAFETY ALERT No. 17-07**

### **Master Link Failure CH330.P.320, HA-32 PL Pear Links**

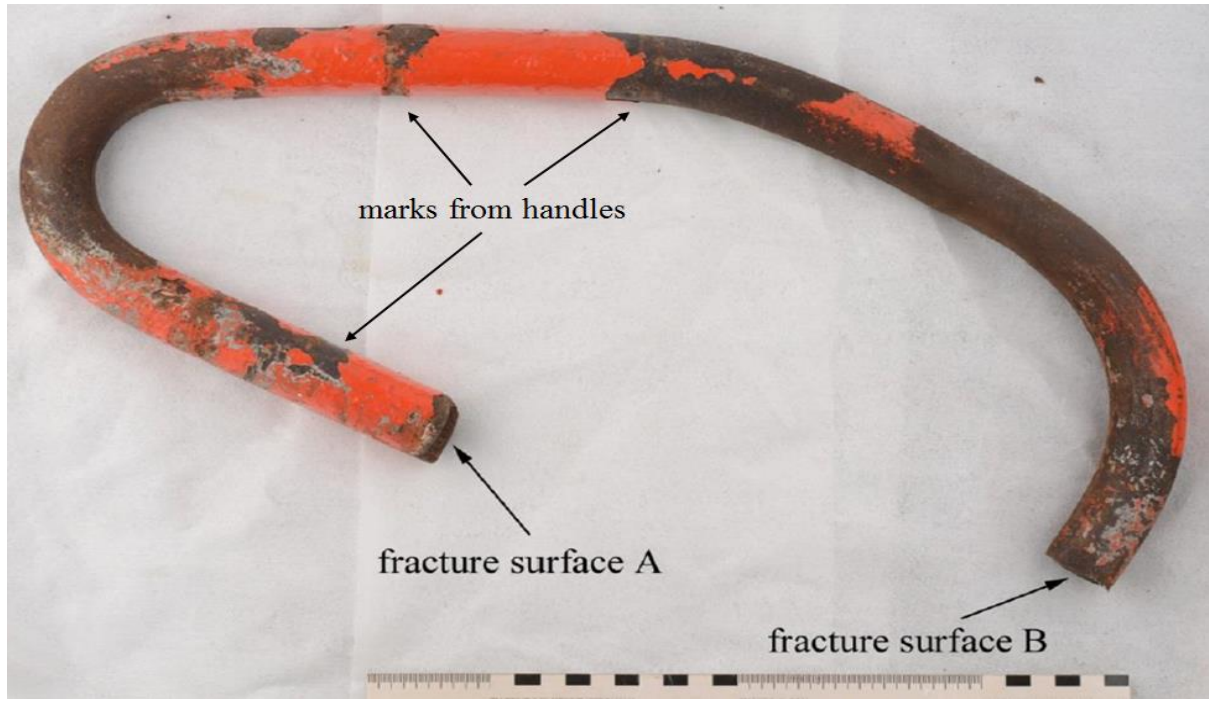
- 2.1 A tender boat onboard a cruise ship registered in the Commonwealth of the Bahamas suddenly fell from its stowed position into the water. The immediate cause was a catastrophic failure of the link that connects the fall block to the release gear/hook (see figure 1). No persons were injured; however, the tender boat itself was a total loss.
- 2.2 An immediate internal investigation was commenced by the Owners who also instructed the vessel's Classification Society to conduct material examination to determine the failure mechanism of the master link. The conclusions drawn from the investigation are detailed below.

Figure 1: Fractured master link with handles removed

- 3.1 The failed connecting link material composition was not in accordance with the supplied certificate. The break load tests conducted on the intact link which is most likely to be from the same batch based on chemical analysis proved that the break load was below what was described on the original certificate in 2009 and below that of the minimum required by the LSA Code (Chapter VI, 6.1.1.6). The certificate and LSA Code both specify a minimum safety factor of 6:1; the actual measured safety factor was between 4.1:1 and 4.6:1 at the time of testing.

- 3.2 The master link suffered a fatigue fracture. The initiation of this is most likely attributed to the location of the stainless steel handle which was attached to the straight part of the link in vicinity of the fracture. The mechanism is believed to be either corrosion fatigue (galvanic corrosion) or fatigue initiated from a minor indent at the surface.

- 5.1 It is recommended that the above information is taken into consideration and the condition of master links be verified by a competent authority to ensure the structural integrity is not compromised. SSI UK Ltd. recommends replacement of lifting links every 5 years.

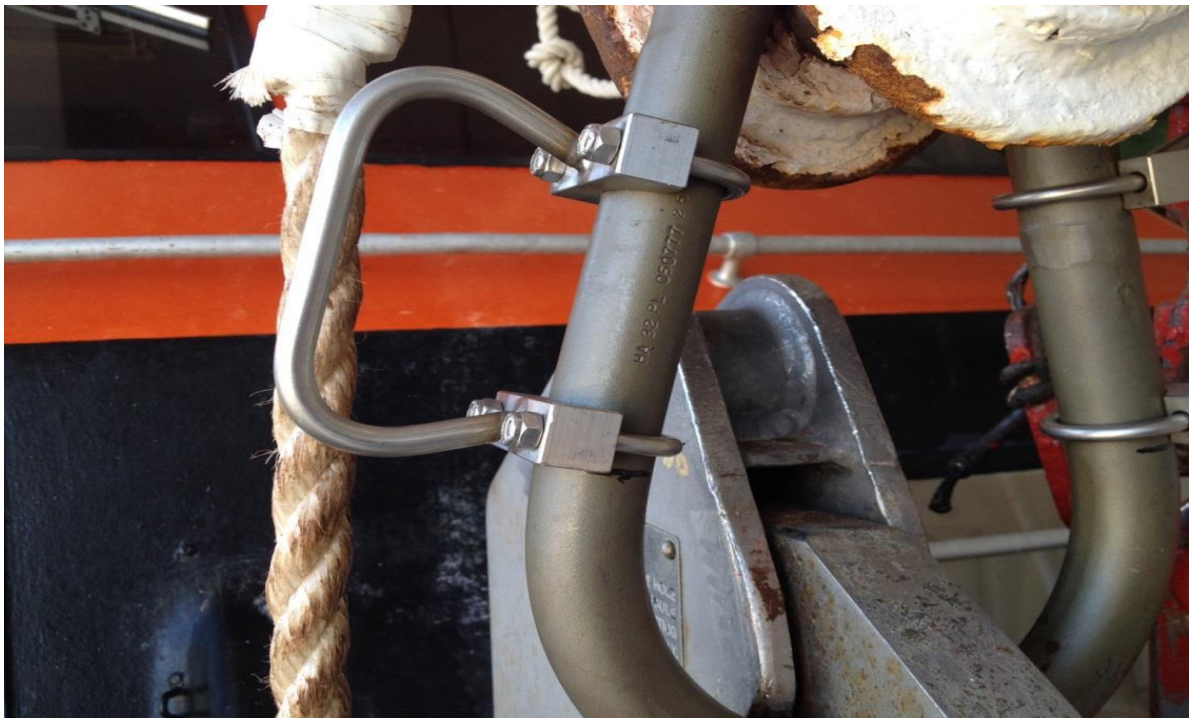
Figure 2: Master link in service with bolted on stainless steel handles

- 3.3 The material used was high tensile strength steel, with increased notch sensitivity. The link was fitted with bolted on stainless steel handles (as per original design and delivery) which serve as an originator of notches into the link, if subjected to outside force or if tightened too hard these can cause potential galvanic corrosion generated by exposure to the marine environment, due to material difference compared to the links themselves.

- 3.4 The addition of these stainless steel handles obstructs complete visual inspection of the links.
