**Transport Safety Investigation Bureau
Safety Flyer – 2017/1**

Accident involving mooring rope

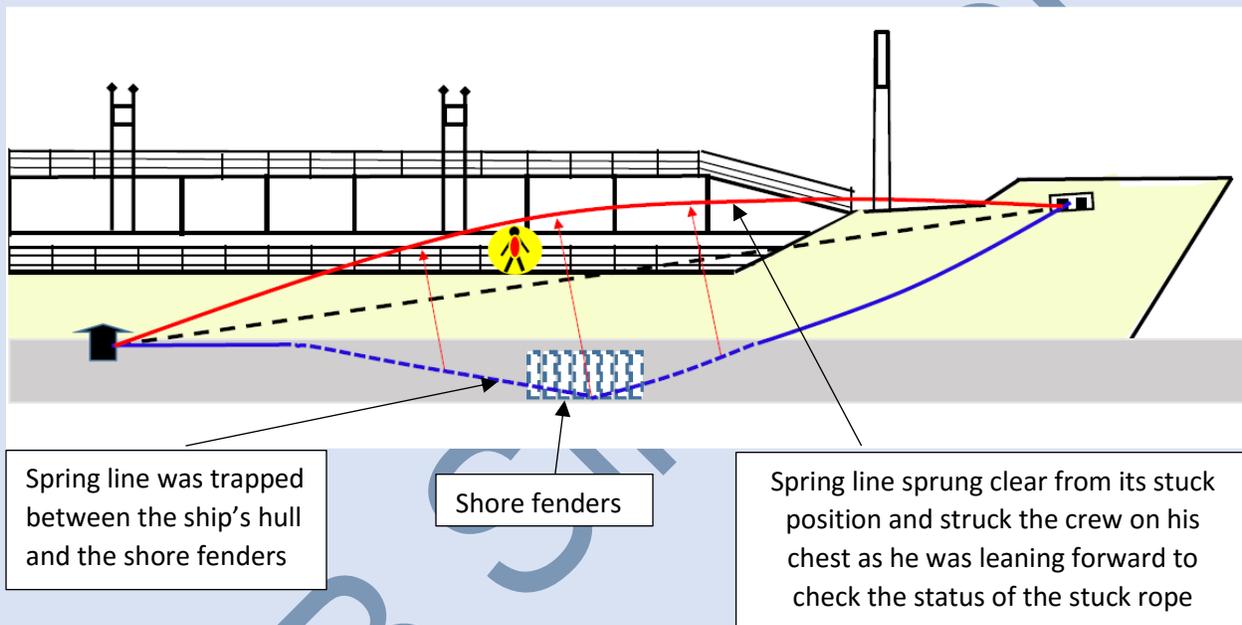
For illustration only - Side View

2. On two separate accidents during berthing operations under pilotage, involving two distinctly different type of ships, one being a bulk carrier, and the other being an oil tanker, the forward spring rope got stuck at the shore fender in the course of being picked up after being secured to the shore mooring hook.

3. The matter was reported to the Bridge by the mooring crew of the respective vessels. To facilitate release of the mooring rope from its stuck position, the assist tug's power was eased off. At about the same time, the stuck mooring rope jumped upwards striking the ship's personnel in-charge of the mooring operation, who was standing next to the railing assessing the status of the rope. It is likely that the mooring rope's slack was picked up almost at the same time as the tug eased off its power to facilitate the released of the stuck rope.

7. It is thus extremely important that mooring operations are recognised within the company's Safety Management Systems as operations that require a thorough risk assessment including the DO's and DON'Ts associated with such operations.

8. As a matter of good practice, personnel involved with mooring operations should be briefed and reminded before every operation to pay particular attention to the safety precautions to achieve a safe mooring operation and ensure proper communications at all times.
