MARINE SAFETY ALERT

Safety Alert 04-19

Confined Spaces: Silent & Invisible Killers

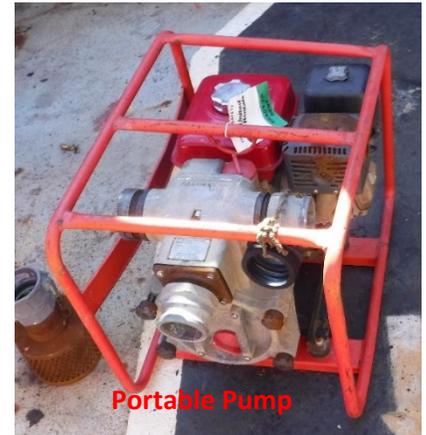
Ten crewmembers were onboard the MODU preparing it for a heavy lift transport to an overseas ship breaking facility. They were successful in dewatering three of the MODU's four legs. However, the de-ballasting system was inoperable in the fourth leg because piping and valves had been previously removed. To continue pumping, the crew rigged a portable diesel engine driven pump to discharge the tanks.

Each leg had six decks. The first two uppermost decks had access hatches that allowed easy transfer of crew and equipment between the decks. The remaining decks were accessed via manhole hatches that were too small to allow passage of the portable pump and had to be enlarged. As each ballast tank was fully discharged, the manhole cover at the bottom of the tank was enlarged and the pump was lowered. Once they reached the lowermost ballast tank, the pump was set up with its suction hose in the tank and discharge hose exiting the leg via a hole torched through its side shell plating. A second smaller hole was also cut to serve as an air supply vent.

- Obtain the requisite level of knowledge and training of confined space entry procedures including emergency and rescue procedures;
- Ensure crews undergo periodic confined space training and participate in routine and practical onboard emergency drills;
- Verify all required confined space entry and rescue safety equipment is onboard, maintained, tested and fully functional; and
- Continually appreciate the dangers involved in confined space entry and educate yourself by further study. A good place to do this are the [reports found on this webpage](#) ¹
