SAFETY ALERT No. 19-02

Serious Crew Injuries on a Passenger Vessel

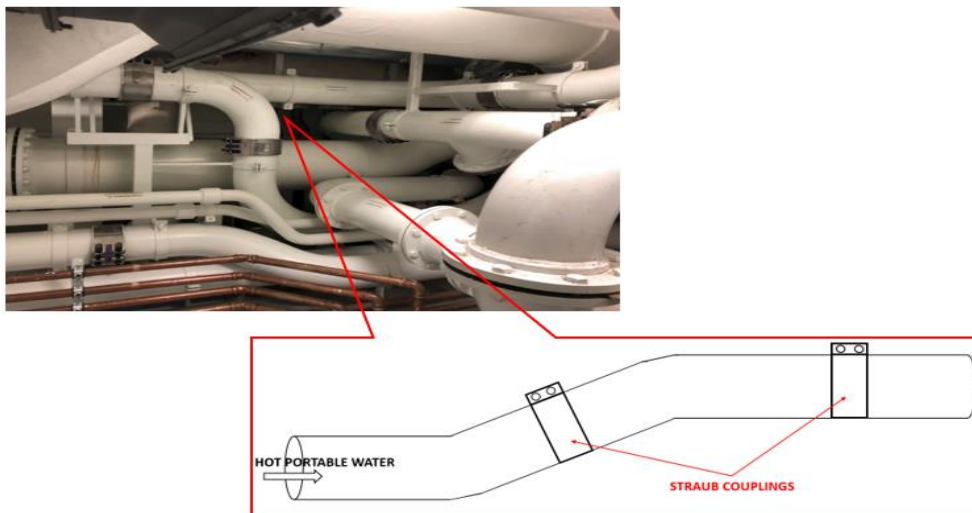
- 2.1. A leak was observed in the area around the insulated hot potable water pipe in the Engine room on deck 2. In the vicinity of the leak, the Hot Potable Water pipeline section had 2 Straub couplings.

Figure 1: Location of Straub couplings² on deck 2

- 3.4. From the forensic evaluation conducted into the failed Straub coupling, it was determined that the Straub coupling failed due to stress corrosion cracking due to exposure of chlorinated water. The likely source of chlorinated water is the leakage through the gasket to the pipe interface.

However, it could not be determined if the leakage occurred as a result of a deteriorating gasket or due to faulty installation of the coupling.
