Transport Safety Investigation Bureau
Safety Flyer – 2019/02

The importance of ensuring proper inspection and maintenance regime

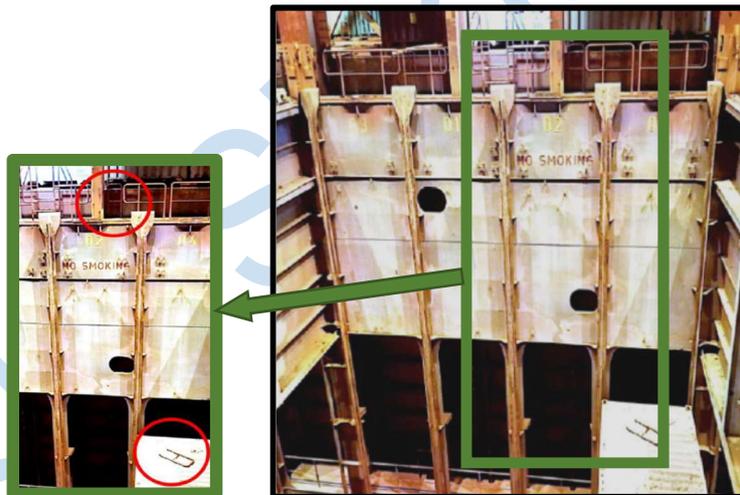
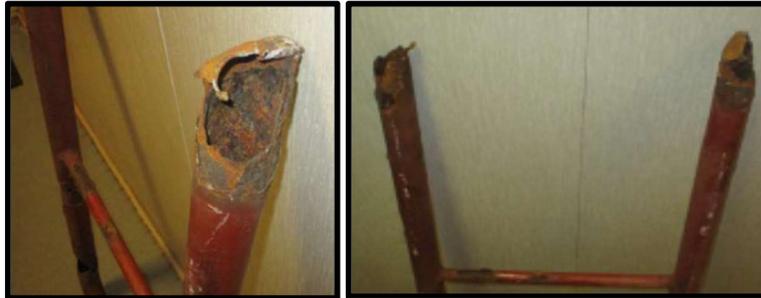
2. Preliminary findings from a marine casualty resulting in a stevedore being fatally injured by falling into the cargo hold of a container ship, revealed that a safety railing, which was in poor condition² and badly corroded, could have contributed to the fall of the stevedore through a height of about 20 metres. Although the corroded safety railing had been identified to be one of the tasks to be carried out on board, there were no safeguards or warning signs put in place to warn personnel in the vicinity of its condition.

Picture 1: Closer examination of the railing revealed severe corrosion (metallurgy thinning) at the bottom joints

8. A comprehensive inspection regime of areas which could pose a threat to the safety of personnel should be in place, so as to facilitate appropriate intervention and priority for carrying out appropriate repairs in a timely manner.

9. Safety barriers / gratings are meant to protect personnel from potential hazards, such as prevention of falling from height. Where safety barriers / gratings are found to be corroded such that their main role of providing functions could be compromised and pose a threat to personnel, shipboard staff should take appropriate mitigating measures by putting up warning signs and cordoning off such areas to the extent practicable and make such observations known to the company.

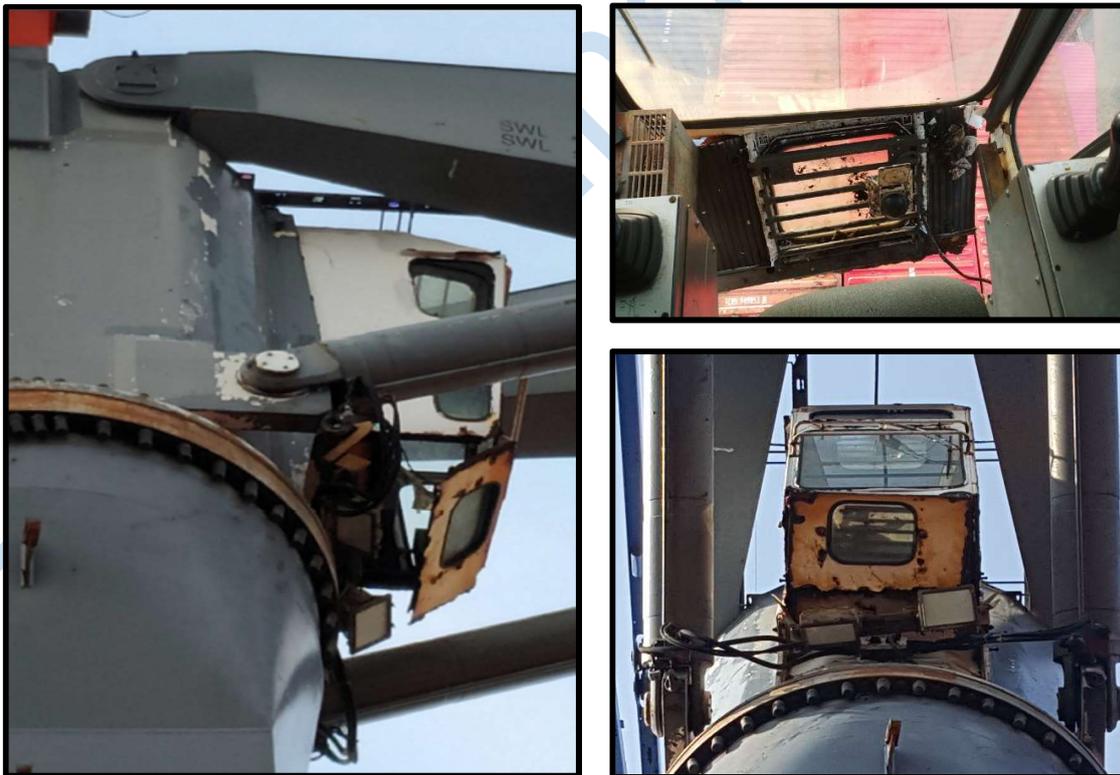
3. In a separate incident, a crew member of a container ship, fell from a height of almost 20 metres, when the base plate of the crane cabin he had just entered in, gave way, and he succumbed to his injuries at the hospital.
4. Preliminary findings revealed that the base plate was severely corroded. Although the company's planned maintenance system covered inspection of cranes, the corrosion of the base plate had not been detected .

Picture 2: Photograph of the base plate of the crane cabin taken after the accident

10. Inspections of areas which are covered by anti-slip mats or any other similar concealments of metallic surfaces, should be carried out in detail especially where the chance of moisture being trapped is high.
