**Inadvertent discharge of a FirePro condensed aerosol  
fire extinguishing system  
during its installation on board the fishing vessel  
*Resurgam* (PZ 1001)  
on 15 November 2019  
resulting in one fatality**

*Resurgam*

## MAIB SAFETY BULLETIN 1/2020

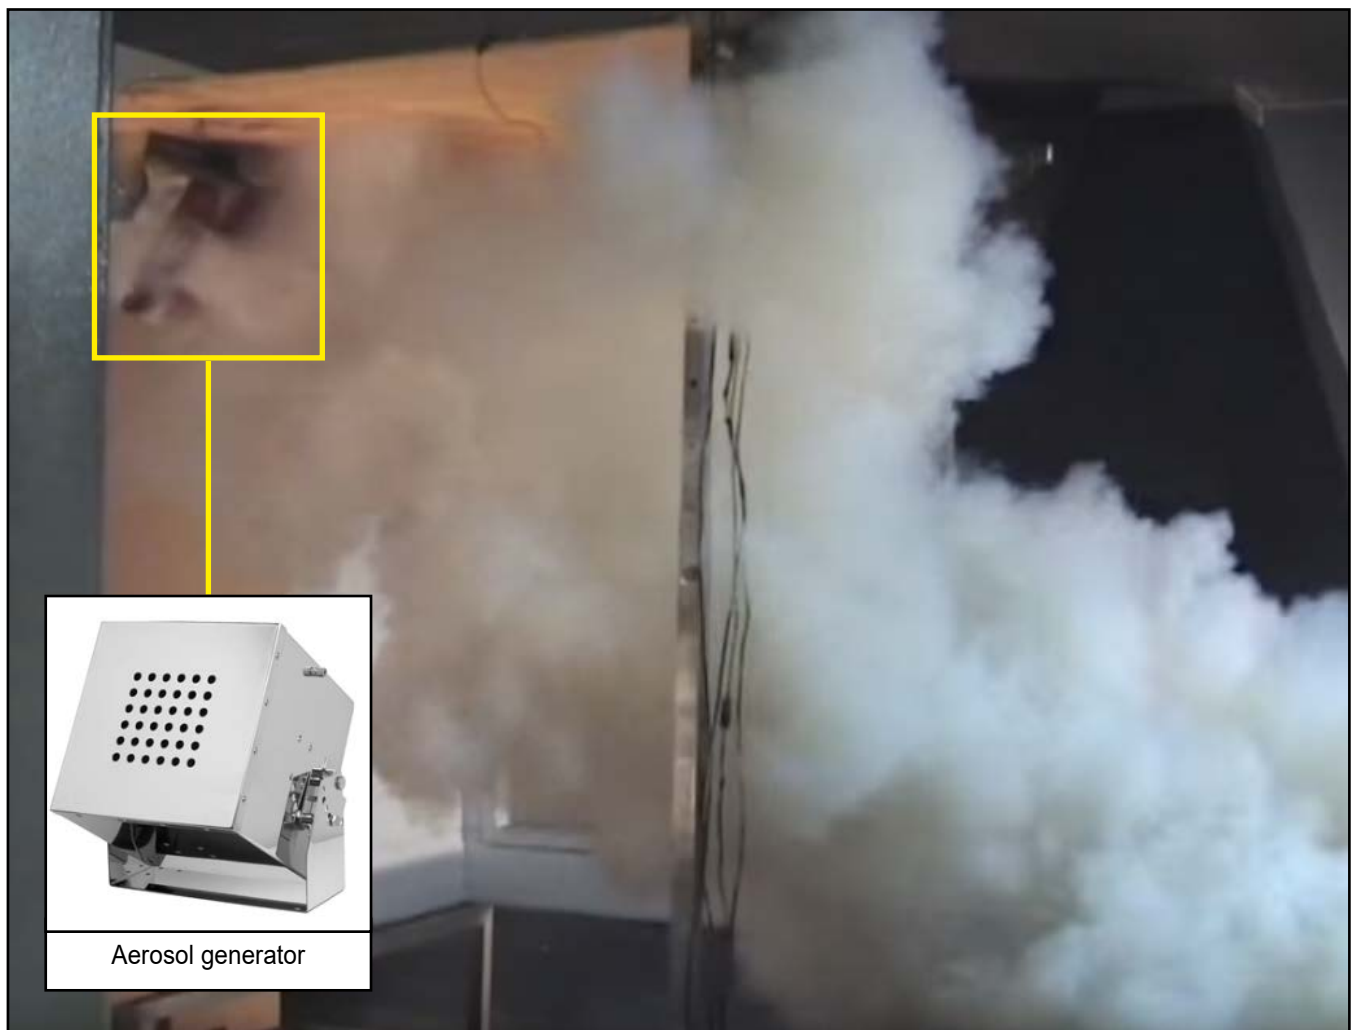
During the installation and without warning, the fire extinguishing system partially and inadvertently discharged, filling the engine room with a dense cloud of aerosol fire suppressing particles (**Figure 1**). Both installation contractors and the company's engineer managed to evacuate, but the apprentice collapsed in the engine room. He was later recovered by the local fire and rescue service but was found not breathing and could not be resuscitated.

**Figure 1:** Typical discharge of a condensed aerosol fire suppressant (not at time of accident)

The exact causes and circumstances of this accident are still being investigated and the findings will be published by the MAIB in a full investigation report. However, during the inadvertent discharge, it is evident that the apprentice inhaled a high concentration of the suppressant particles and this significantly contributed to the fatality.

- Prior to intentional discharge of a condensed aerosol system, there should be visible and audible alarms to alert personnel. Checks should also be made to ensure the protected compartment has been evacuated before the system is activated.
- When condensed aerosol fire extinguishing systems are being installed or maintained the system should be fully isolated to guard against inadvertent activation, non-essential personnel should be clear of the area and an enclosed space rescue plan should be in place.

**S2020/114** Issue a safety alert to the owner/operators of vessels fitted with its systems and its network of marine installation/maintenance engineers highlighting the circumstances of this accident and advising them of appropriate measures to take to reduce the risk of exposure to fire suppressant particles.
