LESSONS LEARNED FROM MARINE CASUALTIES

III 5 (III 5/15, Annex 1)

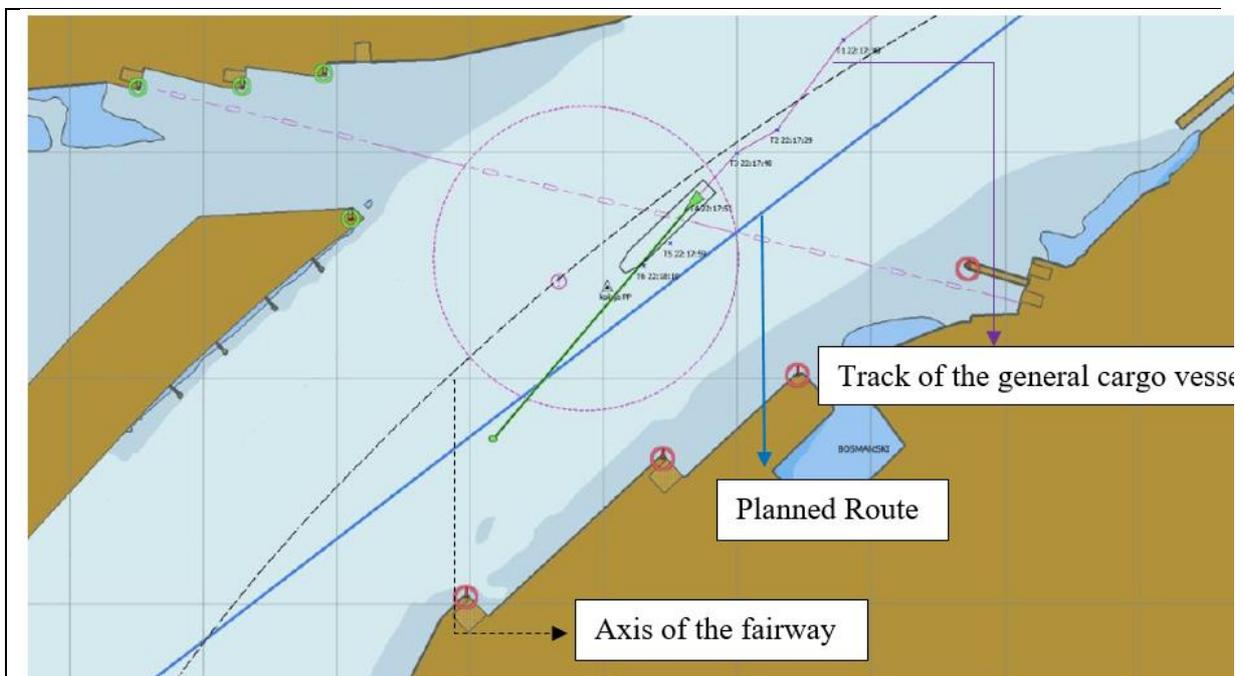
The general cargo vessel was manned only by the master who had not arranged for a proper lookout. Its radar had detected the echo of the tug boat on the starboard side at a distance of about 8 cables, but no action had been taken to determine the passing manoeuvres or to move to starboard to the outer limit of the fairway.

The master had altered his vessel's course following the planned course as laid in his electronic chart, unknowingly positioning his vessel at the wrong side of the fairway.

Photo 1 – The vessel's track (magenta line), the planned route (blue line), axis of the fairway (dashed black line) in the vicinity of the place of collision.

The pilot, during the transit in the fairway, also did not intervene when the general cargo vessel's course was altered to port so as to navigate the vessel on the wrong side of the fairway.
