## Allision Under Pilotage

- 1.1. This Safety Alert is issued by The Bahamas Maritime Authority to share lessons to be learned from an allision with a pier structure that occurred with a pilot onboard. It is based on the preliminary findings of an investigation into a marine casualty.

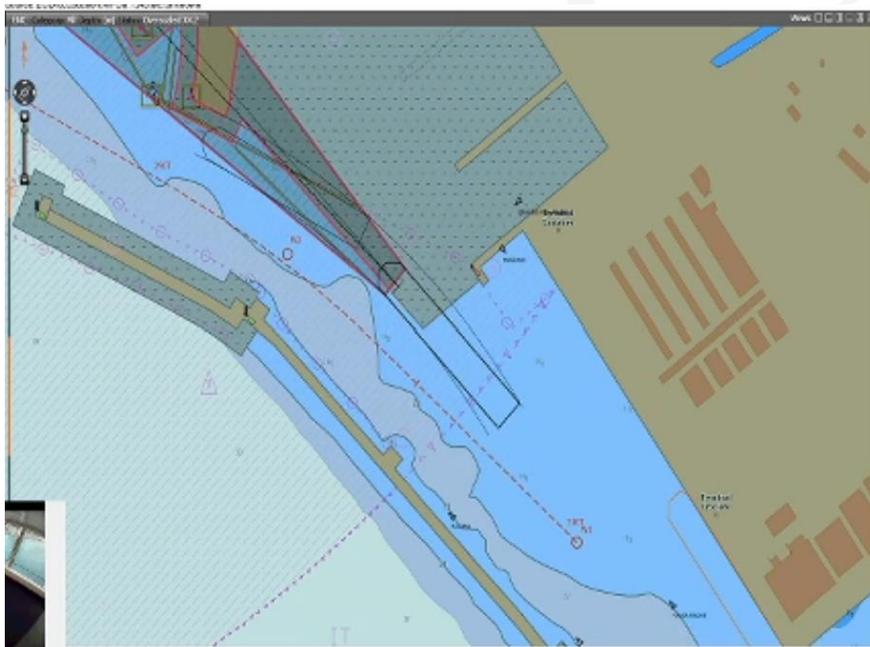
- 2.3. After a series of course orders from the pilot that did not address the vessel's deviation from planned track, the master took control of the vessel. His actions were not sufficient to avoid an allision which resulted in significant damage to the hull above the waterline. No one was hurt and there was no pollution.
