## Grounding After Dragging Anchor

- 1.1. This Safety Alert is issued by The Bahamas Maritime Authority to share lessons to be learned from a grounding that occurred after a ferry dragged anchor. It is based on the preliminary findings of an investigation into a marine casualty.

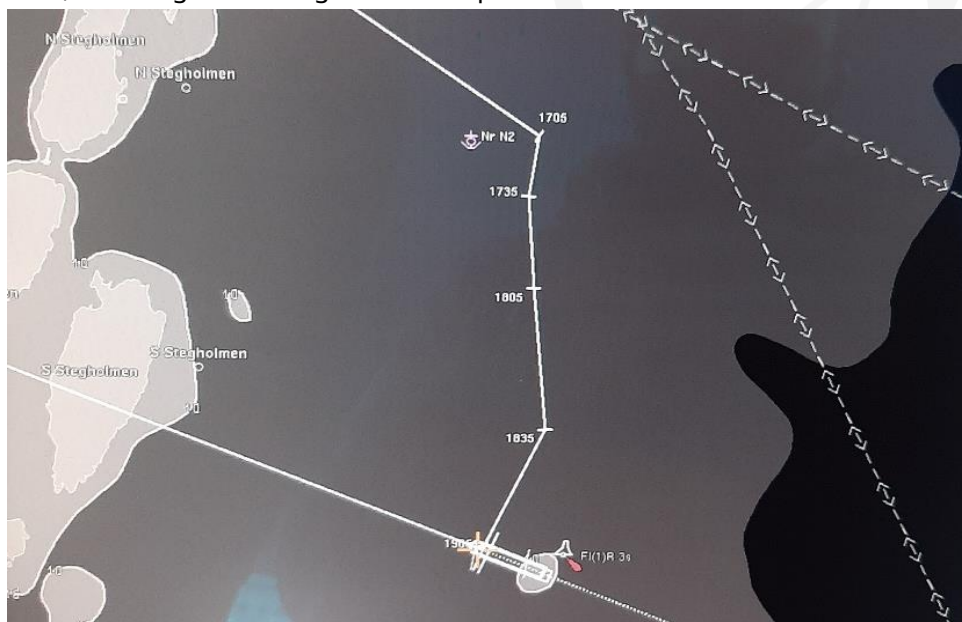
- 2.1. Due to congestion at the terminal, a Bahamas registered ro-ro passenger ferry anchored in the designated anchorage outside the harbour. With gale force winds from the north, the ferry anchored with four shackles on deck in 29m of water, approximately 0.7 nm due north of a charted (and buoyed) obstruction.

- 2.2. Within 11 minutes of letting go the anchor, the master declared the vessel brought up and handed over to the second officer when he returned from the focsle. Unnoticed by either of them, the vessel was dragging before the master left the bridge. The second officer remained on the bridge for the next 40 minutes, occasionally checking the vessel's position by using the radar's variable range marker against the land to the west.

- 2.3. 10 minutes after taking over the watch, the third officer suspected the vessel was not in position and called the master who, after a delay, requested engines and sent a anchoring party forward. An hour later, the vessel grounded on the charted obstruction, stern first, resulting in flooding to two compartments.
