## Rope Access – fatal fall

- 1.1. This Safety Alert is issued by The Bahamas Maritime Authority to share lessons to be learned from the death of a rope access technician inside a cargo tank. It is based on the preliminary findings of an ongoing investigation into a very serious marine casualty.
- 1.2. Many of the lessons to be learned from this casualty are for rope access technicians, companies and training establishments but vessel operators should be aware of the need to imbed contractors' hazard identification into shipboard task risk assessments and permits to work in order to effectively control risks of all tasks being conducted onboard.

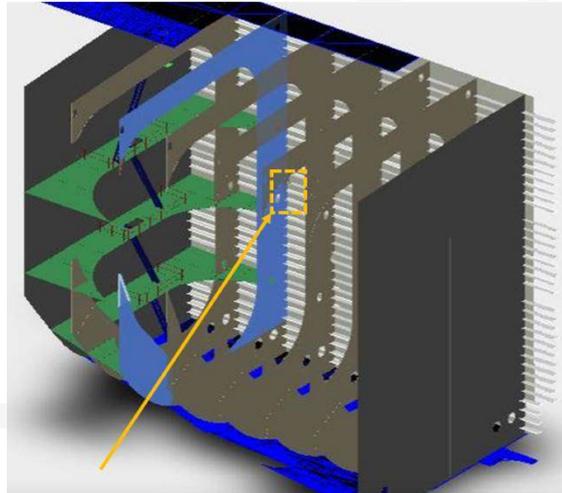
- 2.5. Available evidence suggests that, prior to the fall, the victim was suspended from a single working line that terminated with a karabiner hooked over the edge of a lightening hole or welding scallop – when the suspended weight was momentarily removed, the karabiner slipped and the system failed.

Approximate location of victim before fall

- 4.1. The correct use of equipment, and selection of appropriate anchor points, is fundamental to safe rope access.
- 4.2. The principle of double protection from a fall is at the heart of a rope access safe system of work. It is essential to include additional means of protection (such as a safety line) to prevent a single point failure.
