SB1/2022

**Blockage of fixed CO₂ fire extinguishing system
pilot hoses identified following a fire
on board the roll-on/roll-off cargo ship
Finnmaster
in Hull, England
on 19 September 2021**

MAIB SAFETY BULLETIN 1/2022

The Marine Accident Investigation Branch is carrying out an investigation into the fire on board the roll-on/roll-off cargo ship *Finnmaster* in Hull, England, on 19 September 2021.

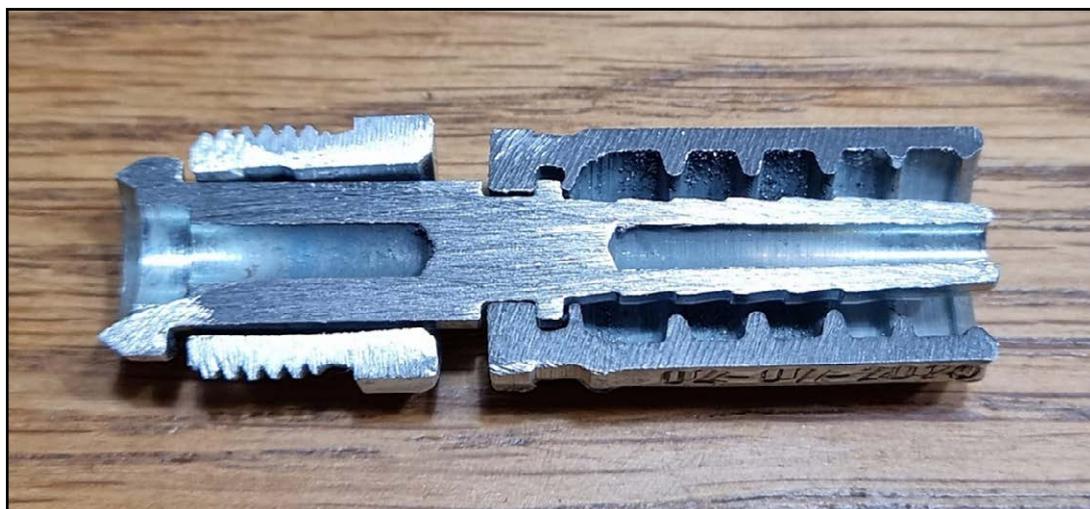
Section through blocked CO₂ pilot hose coupling showing incomplete bore through the stem

The initial MAIB investigation identified that one of the auxiliary engine room's CO₂ system pilot hoses was completely blocked. Subsequent examination and testing of *Finnmaster*'s fixed fire extinguishing systems identified two other hoses on the cargo hold pilot line system that were blocked. Radiographic images taken of the blocked hoses (**Figures 2 and 3**) showed that the pilot hose couplings had not been fully bored through during the manufacturing process. The testing process also identified several coupling leaks in the pilot lines.

- The quality assurance processes of the pilot hose assembly supplier did not identify that the hose couplings had not been fully bored through.
- Viking's onboard installation testing processes did not identify both that some of the hose assemblies were blocked and that there were leaks in the CO₂ system pilot lines.

S2022/107M Take immediate remedial action to identify and rectify any blocked pilot hose assemblies and pilot system leaks on potentially affected CO₂ fire extinguishing systems.

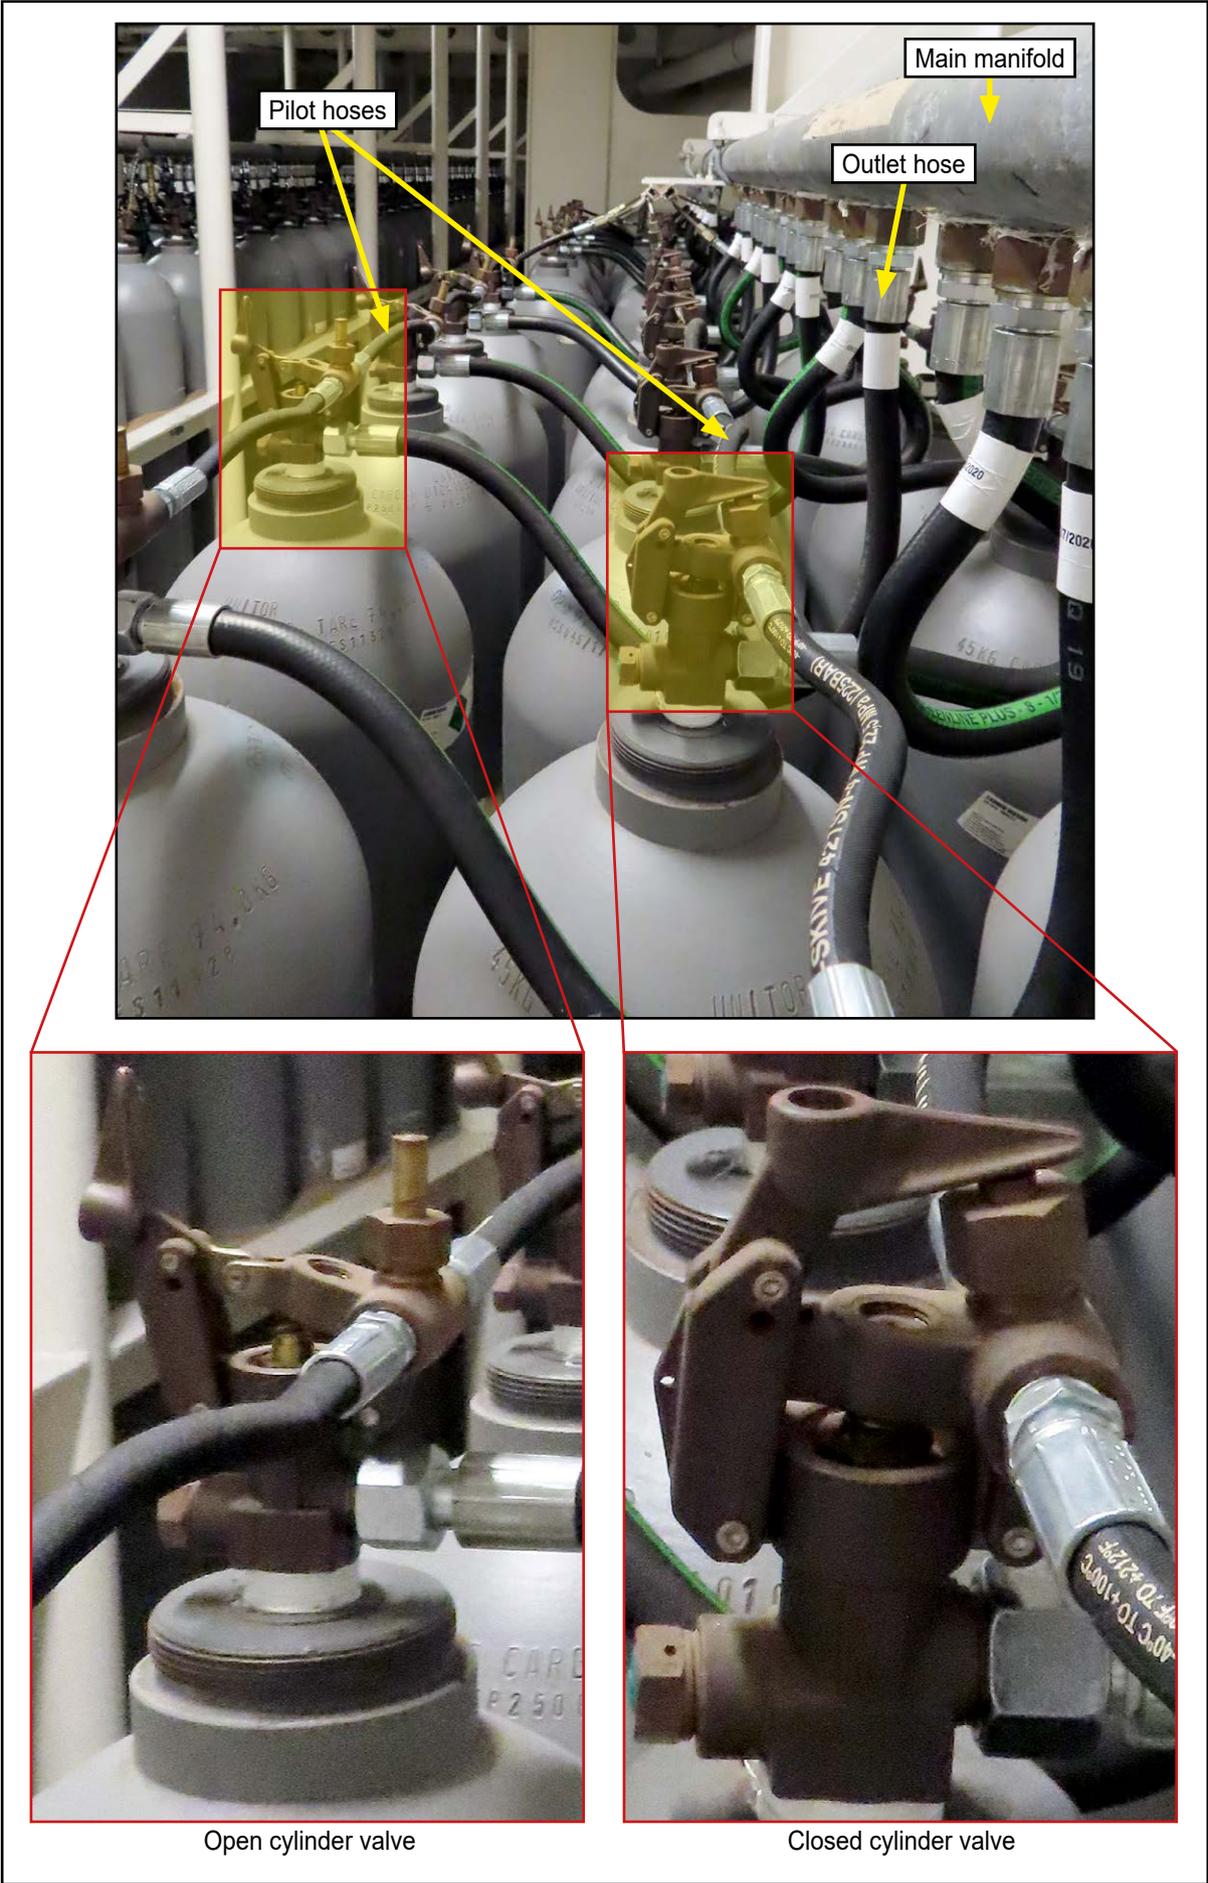
Figure 1: Part of the *Finnmaster* CO₂ fire extinguishing system post-accident

Finnmaster was operated by Finnlines Oyj (Finnlines) and was equipped with a fixed high-pressure CO₂ fire extinguishing system that provided protection for the ship's machinery spaces, encompassing the main engine room and the auxiliary engine room, and the two cargo holds. The system was designed to be activated remotely via a network of pilot lines and gas activated cylinder valves (**Figure 1**).
