MARINE SAFETY ALERT

Safety Alert 04-22

VERIFY GATEWAY HANDHOLD ARRANGEMENTS **Incorrect Terminations Can Lead to Marine Casualties**

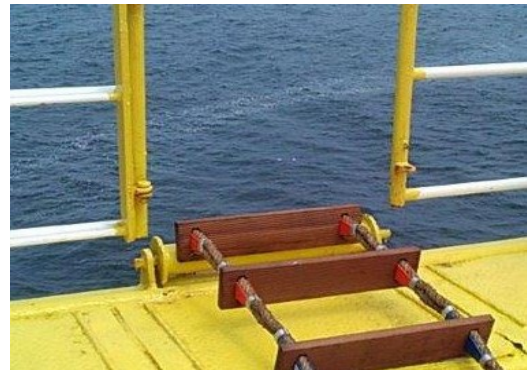
The Coast Guard is currently investigating a casualty involving a fall from a pilot ladder where the handholds in the gate arrangement aboard the vessel terminated without being rigidly secured to the vessel's structure. This termination left a gap in the handholds at the transition point at the head of the pilot ladder, where an embarking person might reach to pull themselves onto the vessel (Figure 1).

Figure 1: Handholds that terminate above the vessel structure.

- Ensure familiarity with applicable requirements pertaining to handholds in gateway embarkation arrangements aboard merchant vessels.
- Visually examine handholds in gateway embarkation arrangements for gaps, specifically at the lower terminations.
- Initiate rectification and issue outstanding conditions to meet regulatory intent for any non-conformities discovered.

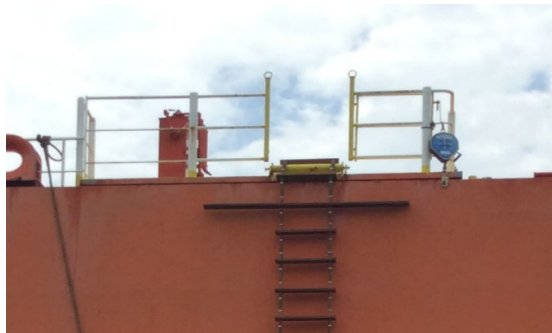
Figure 2: Gap in handholds appear to accommodate spreader.

The Coast Guard observed that the abrupt termination of the handholds above the vessel structure appeared to be a modification that was completed to accommodate the length of the pilot ladder spreader during deployment and retrieval of the pilot ladder. The modification made it possible to retrieve the pilot ladder without having to lift the spreader up and over the vessel's railings (Figure 2).
