UNITED STATES COAST GUARD

MARINE SAFETY ALERT

Safety Alert 10-23

WOOD PELLET FIRE HAZARDS

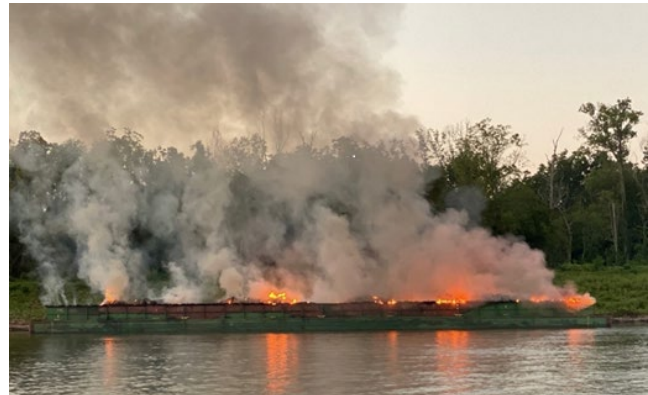
Over a two-week span, two unmanned and uninspected hopper barges loaded with wood pellets containing binders caught fire while awaiting transport at a Mississippi River fleeting facility. Each fire caused approximately \$355,000 in damage, including total cargo loss and significant vessel damage. The ignition source for both fires was spontaneous combustion, which is not common, but also not unprecedented. The International Maritime Solid Bulk Cargoes Code notes that “wood pellets containing additives or binders may ferment over time if moisture content is over 15% leading to generation of asphyxiating and flammable gases which may cause spontaneous combustion”.

Assessment of other fleeted wood pellet barges revealed the presence of several hazards that can lead to spontaneous combustion, including visible moisture, cargo decay and discoloration, elevated cargo hold temperatures (168°F), and carbon monoxide and hydrogen sulfide gas generated by cargo decomposition. Some of these conditions likely preceded both fires. Unfortunately, the first identified hazard was visible smoke from already smoldering pellets. Heat from the smoldering cargo melted the hopper covers, introducing oxygen to a volatile situation, and supporting rapid and uncontrollable fire growth.

Figure 1- Hopper Barge Fire Loaded with Wood Pellets

- Take steps to isolate cargo from external moisture sources, including ceasing cargo operations during inclement weather and maintaining hopper covers to prevent rain ingress during transport.
- Plan deliveries to minimize long term storage, particularly on board barges.
- Conduct routine temperature readings to detect early-stage cargo decomposition.
- Ensure personnel conduct frequent rounds to identify signs of smoldering.
