MARINE SAFETY ADVISORY No. 06-24

Subject: INCIDENTS INVOLVING THE STORAGE AND HANDLING OF STEEL PLATES

Date: 20 June 2024

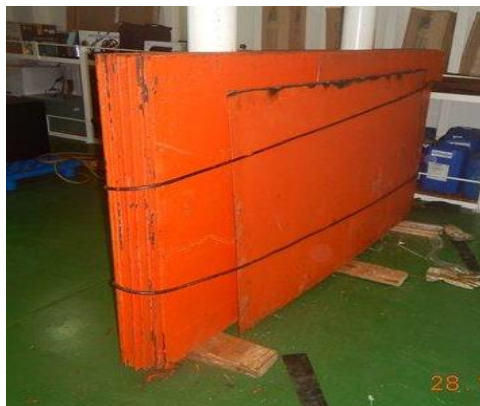
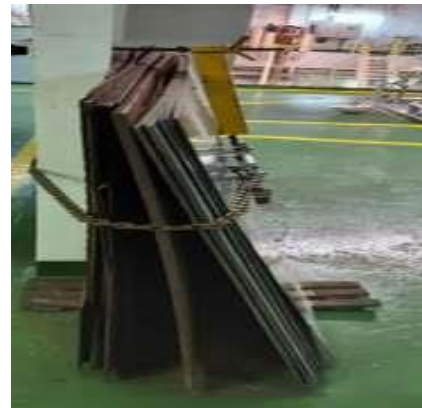
- In eight of the reported incidents, steel plates were stored vertically by leaning them against a stanchion or bulkhead and secured using lashings or a retaining bar¹ to hold them in place (see Figure 1). Materials used for lashings included rope, web straps, and chain. If a retaining bar was used, it was typically secured using studs that were welded to the bulkhead and held in place with nuts. In the other three incidents, the steel plates were stored on purpose-built storage racks that used a retaining bar located along the length of the storage rack to hold the plates in place. The retaining bars were secured using either bolts or studs and nuts. The lashings or the retaining bars had to be removed to handle the steel plates. As a result, there was always the potential for the steel plates to fall whenever they were being handled.

Figure 1: Examples of steel plates stored using lashings.

- Whenever possible, steel plates are stored horizontally in a location where lifting equipment can be used to lift and move the plates.
- If steel plates must be stored vertically, they are stored on racks that have a mechanical means of preventing the plates from falling prior to removal of the securing mechanism, and before being handled.
- Racks designed for storing steel plates vertically are oriented athwartships rather than along the ship's longitudinal axis.
- A Toolbox Talk and pre-task risk assessment is conducted to identify and remove the risk of personal injury before handling steel plates.
- The crewmembers are encouraged to use their Stop Work Authority to challenge any unsafe practices.
- Adequate lifting and/or manual handling equipment is located at the work site.
