MIR-26-02

# Diesel Generator Engine Failure aboard Self-unloading Barge *Pathfinder*

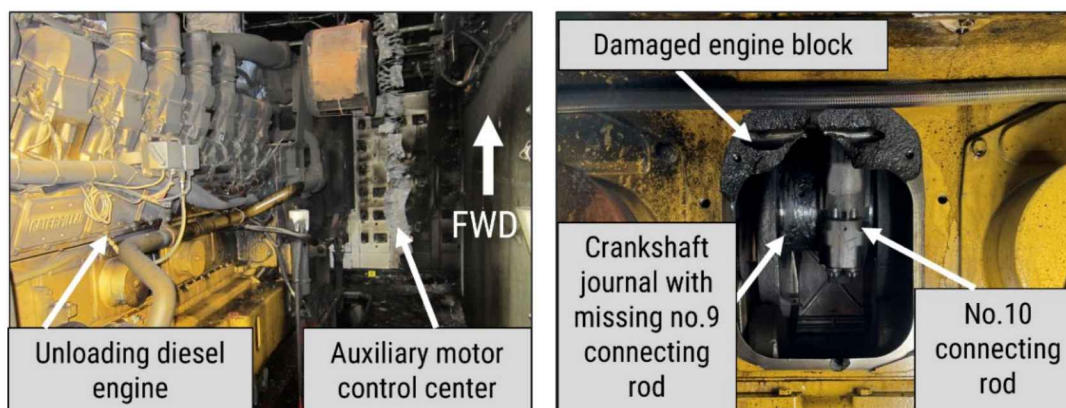
NTSB and Coast Guard investigators noted block damage of the unloading diesel generator engine in the area of the no. 9 connecting rod, where internal components had forcefully exited the engine. The exterior of the engine forward of the damaged block showed signs of heat and smoke damage on the starboard side. The unloading generator had smoke and heat damage on the exterior surfaces, and after removing panels, investigators observed damage to internal components such as wiring insulation and electronic measuring devices. The front panels of the auxiliary MCC showed heat and smoke damage with several melted breakers. The overheads and bulkheads above and forward of the no. 9 connecting rod were covered in soot.

The company electrical systems technician reported that the auxiliary MCC had extensive fire damage, which was most pronounced in the area forward of the generator (see figure 4). Several circuit breakers were completely melted with only their openings left in the panel. The electrician removed the panels and inspected the generator's internal components. The fiberglass busbar support was severely burned

**Figure 4.** Left to right: Unloading diesel engine and auxiliary MCC after the fire and damaged engine block in the area of the no. 9 connecting rod.

The City of Cleveland FIU produced a report that indicated the most severe fire damage by the engine was about 5 to 10 feet to starboard and forward of the area of the damaged engine block where internal components had forcefully exited the engine block (in the area of the no. 9 connecting rod), and the auxiliary switchboard sustained fire damage "extending to several cabinets and consuming some components." The report identified the area of origin to be "between the generator and auxiliary switchboard due to observing extensive fire damage in the area."

The damaged engine block and generator were replaced aboard the *Pathfinder* in May 2025.

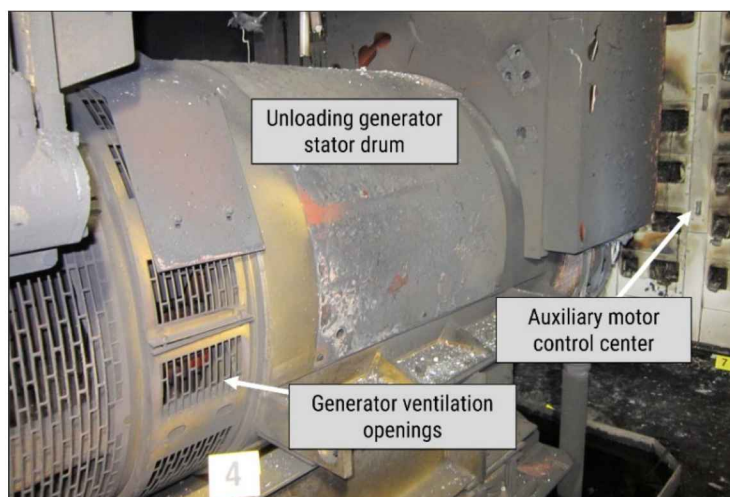
and partially collapsed. The generator's winding (stator) leads attached to the busbar experienced extreme heat with the insulation burned off, but the remainder of the insulation on the generator's stator leads appeared to be normal (see figure 5). The stator turns on the field and rotor (that could be observed without disassembly) also appeared normal with no signs of heat, and the lacquer color was normal.

**Figure 5.** Damaged exterior of the unloading generator after the fire. (Background source: Coast Guard)

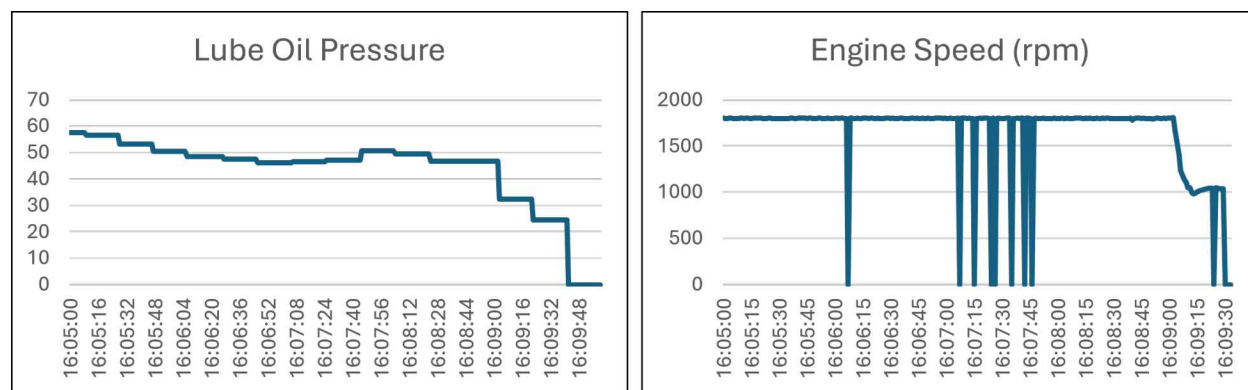
Investigators reviewed the data logs and alarm history from the vessel's engine room machinery automation system. There were no alarms associated with the diesel engine, unloading generator, or electrical system on the day of the failure. The engine's speed was recorded at 1,800 rpm (varying 1-2 rpm) and lube oil pressure, provided by a positive-displacement, engine-driven gear pump, was recorded at 58 pounds per square inch (psi) (varying about 1 psi) from midnight on December 30 until about 1605 (see figure 6).<sup>3</sup> At 1605:28, the lube oil pressure dropped to 53 psi (see figure 6). Nineteen seconds later, the lube oil pressure dropped to 50 psi and then 47 psi until 1607:44. Throughout this time of reduced lube oil pressure, the engine speed remained about 1,800 rpm, the fuel oil pressure to the engine remained constant, the jacket water temperature increased 3°F, and the right bank exhaust temperature increased from about 750°F to over 900°F.<sup>4</sup> At 1609:02, the engine speed increased to 1,810 rpm for one second, and the lube oil pressure remained at 47 psi. Over the next 8 seconds, the engine speed reduced to about 1,000 rpm, and the lube oil pressure dropped to 32 psi. The alarm history showed low frequency and low voltage alarms during this time. At 1609:22, lube oil pressure dropped to 24.5 psi and then to zero at 1609:42. The engine speed dropped to zero at 1609:54.

**Figure 6.** Left to right: Graph of unloading diesel engine lube oil pressure from 1605 to 1609 and graph of unloading diesel engine speed (rpm) from 1605 to 1609.

The most severe fire damage was about 5–10 feet from the damaged engine block near the no. 9 connecting rod, where internal components had forcefully exited the engine. In the 4 minutes leading up to the discovery of the fire at 1609, the engine control room machinery automation system recorded a decrease of lube oil pressure while the engine was running at rated speed (1,800 rpm). The engine stopped at 1609:30. This loss of pressure (from 58–47 psi) was not severe enough to activate the low-pressure lube oil alarm, so the watchstanding crew was unaware of it. A loss of lube oil pressure would have allowed excessive movement outside of the clearances between engine components, resulting in a loss of oil film between the rotating components. Without an oil film, the friction of rotating components would have generated excessive heat, causing components, such as the no. 9 connecting rod and the crankshaft, to seize together at the journal and fail. Given the extensive fire damage in this area, the fire originated on the starboard side of the unloading generator engine when the engine block ruptured in the area of the no. 9 connecting rod and hot, atomized lube oil vented through the damaged side cover and ignited off hot components internal to the engine.

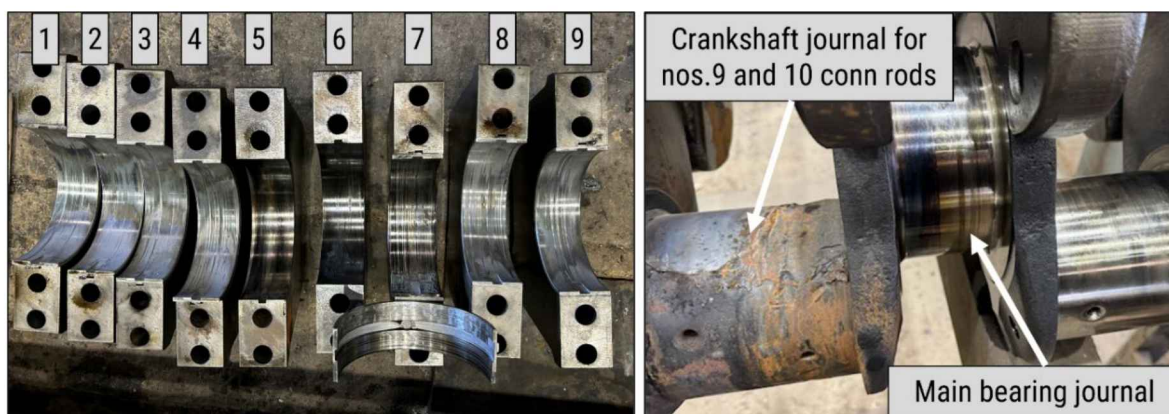
In the months after the casualty, technicians from the operating company removed the damaged engine and generator from the barge and disassembled and inspected the internal components. The engine's main bearings showed debris damage on the bearing surfaces, particularly in the nos. 5, 6, and 7 bearings (see figure 7). All cylinder heads were removed with no damage observed. The crankshaft was removed, and appeared to be intact with no cracks, with damage on the journals in the area of the no. 9 connecting rod and adjacent journal surfaces.

**Figure 7.** Left to right: Removed main bearings from the unloading engine of the *Pathfinder* after the fire and damaged crankshaft in the area of the nos. 9 and 10 connecting rods.

oil pump) did, the loss of lube oil pressure would have likely been through an internal engine component. After the casualty, technicians from the operating company disassembled the damaged engine and generator and inspected the internal components. The postcasualty main bearing inspection identified surfaces that showed signs of debris damage, which could have occurred prior to the engine failure or during the event. Debris in the system would have caused scratching or scoring of the inner layer of the bearings (which typically had an aluminum-based alloy layer) as the debris circulated through the rotating components. As the debris wore away the bearing surfaces of the main bearings and connecting rod bearings, the clearances between the components would have begun to increase between the journals, crankshaft, and bearings. These increased clearances would have allowed more lube oil to flow out the sides of the bearings, ultimately resulting in a loss of oil film between the rotating components and generating excessive heat. However, since the origin of the debris is unknown, investigators could not definitively determine whether the debris damage occurred before or during the engine failure.

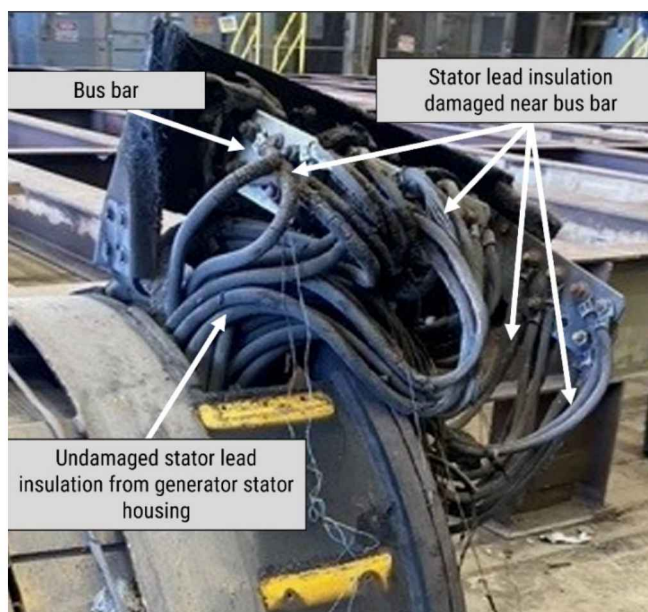
Company technicians removed the generator from the *Pathfinder* and inspected the damage. They reported incinerated insulation on the stator leads with evidence of burning and provided an explanation of the failure sequence based on the postcasualty condition of the internal generator components (see figure 8). Their report stated that "a phase to phase short occurred on the generator side of the bus

bar (before the breaker), which caused an arc and fire as well as extreme 'block loading.'"<sup>6</sup>

**Figure 8.** Disassembled generator from *Pathfinder* showing insulation damage on stator leads. (Background source: Interlake Steamship Co.)

The company technicians' report further stated that the short caused a sudden increase in current and drop in magnetic field, and the generator's voltage regulator, sensing this, increased the output to maintain the magnetic flux around the rotor. The magnetic field became so strong that it acted as a brake on the rotor, and because the rotor was connected to the engine crankshaft, the engine speed decreased. To correct this decrease in engine speed, the ECM increased fuel to the diesel engine to keep it running at speed, but the magnetic field continued to counter this. The report stated that these counteracting forces "created extreme torsional loads and crankshaft deflections, allowing the crank shaft journal to penetrate the thin oil film barrier between the journal and bearings." The report concluded that the "catastrophic diesel engine failure" was caused when the main bearing began to rotate (spin) in its saddle, "misaligning its lube oil holes and thereby starving the main bearing journal and the no. 9 connecting rod bearing journal of lubricating oil."

The technicians' postcasualty examination of the damaged generator found damaged insulation on the stator leads within the generator housing. The leads showed burned insulation close to the busbar; however, the remainder of the cables' insulation was unburned throughout the generator housing. The localized insulation damage was likely electrical in nature, rather than caused by fire, which lends credence to the conclusions in the technicians' report. However, investigators were unable to confirm the company technicians' analysis. There were no recording or automation devices within the electrical switchboard or engine room machinery automation system that could have identified an electrical fault at any time before the engine failure. The ECM for the unloading generator engine was not equipped to identify exact times for alarms and operating parameters such as speed, engine load, and exhaust temperatures. The chief engineer was not aware of any electrical
