December 10, 2025

MIR-25-44

## Flooding and Sinking of Towing Vessel *Cajole*

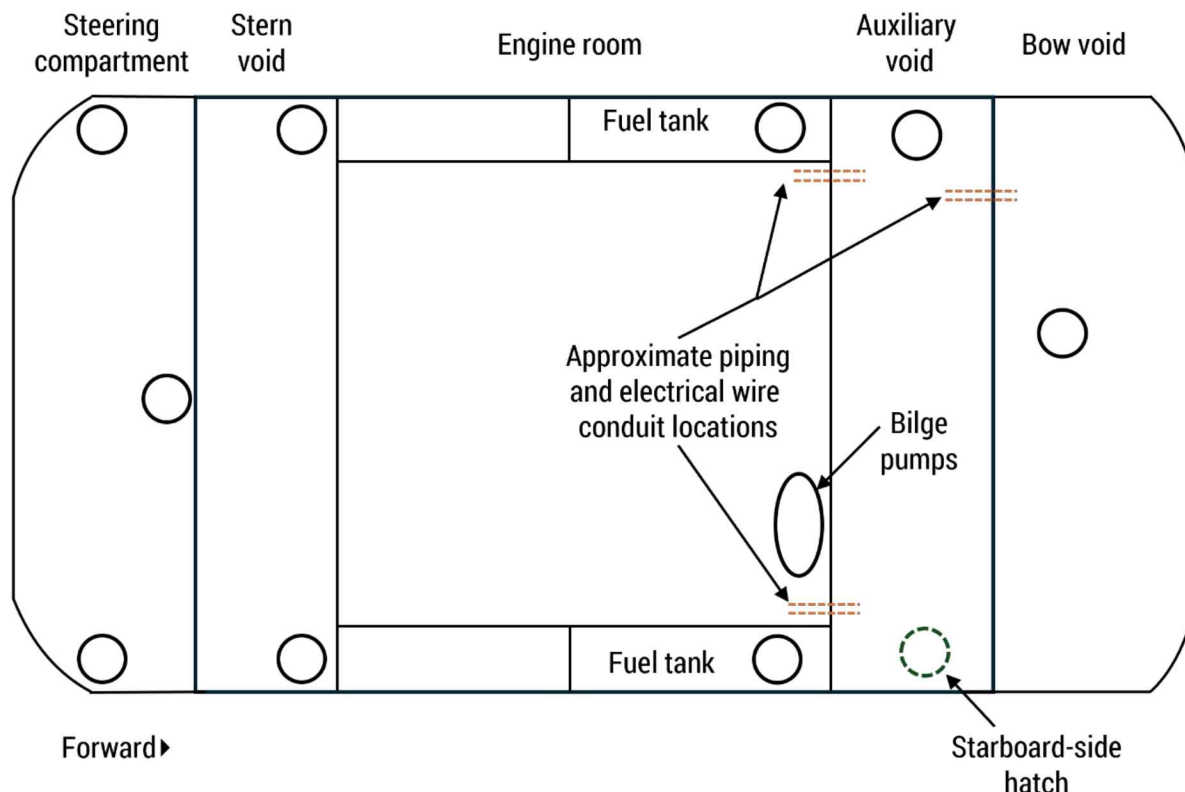
Two sections of 4-inch diameter open-ended steel pipe penetrated the bulkhead between the auxiliary void and engine room, and one 4-inch-diameter steel pipe penetrated the bulkhead between the auxiliary space and bow void. The open-ended pipes (serving as conduits) allowed vessel piping and electrical wire runs to pass through athwartship bulkheads separating the spaces. The openings were about 6-12 inches beneath the main deck near the outboard longitudinal bulkheads (see figure 3).

**Figure 3.** Simplified *Cajole* below deck arrangement with approximate conduit locations indicated with orange dashes and approximate locations of flush-mounted main deck hatches shown as circles

Partway through the transit, the captain reported that the vessel was losing speed; he later entered the engine room and saw water entering the engine room space from the forward starboard corner near a bulkhead penetration (conduit). There were two spaces forward of the engine room's forward bulkhead: the auxiliary space and bow void. After the towboat was salvaged, investigators found no hull damage that would have allowed water ingress into these spaces. According to the captain, the cover on an access hatch to the starboard-side auxiliary void was in place when he discovered the flooding in the engine room. The cover was lost during the casualty, so investigators were not able to evaluate its condition. The hatch was flush to the main deck, and with the vessel's low freeboard, would have made it easy for water to enter if the cover was compromised or not sealed. It is not uncommon for water to wash over a towing vessel's bow as it transits through a river, especially in lightboat condition, like the *Cajole* when it departed the shipyard. AIS data showed that, about 1102, the captain turned the vessel to port so that the vessel was perpendicular to the river, and the vessel started to slow down soon afterward. This turn exposed the starboard side of the vessel to the river current and could have resulted in water rushing over the starboard side and into any insufficiently sealed seams (degraded gasket or poor hatch fit) or an unsecured hatch cover that partly, or fully, slid off the starboard-side auxiliary void hatch opening. Additionally, although the crew activated the engine room bilge pumps and used four portable pumps from Good Samaritan vessels, the pumps could not keep up with the rate of flooding, which indicates a large opening, such as an access hatch opening, was needed to produce this rate of flooding. Given the lack of other potential sources of ingress, it is likely water entered through a compromised (partly secured, or unsecured and displaced underway) auxiliary void access hatch.

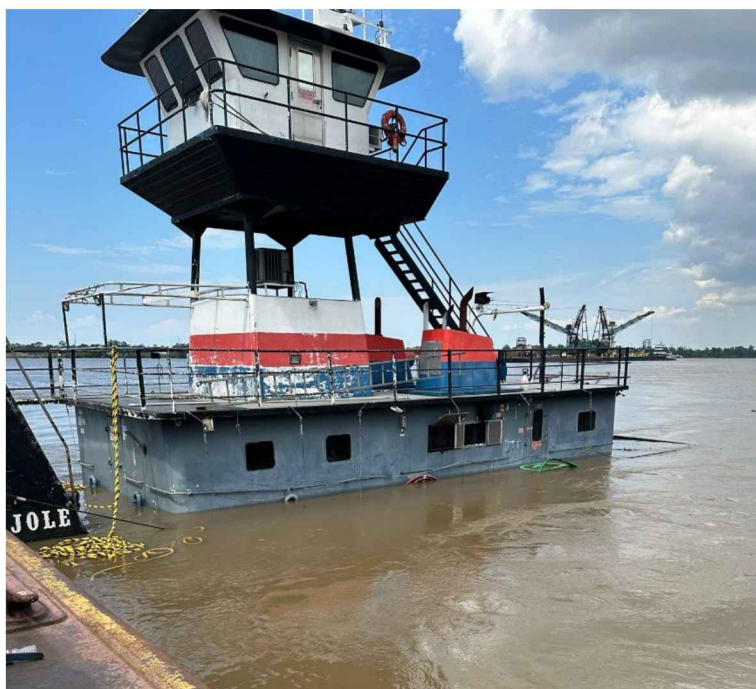
water from both sides of the auxiliary void (two on the starboard side and two on the port side). However, even with the four pumps running, water continued to flood the engine room, so the captain moved two of the pumps into the engine room and ran them in that space. According to the captain, at this time, the water was “a little more than around shin deep” in the engine room. The captain and deckhand sought refuge on board the *Mary Parker*. The vessel, now partially submerged, remained tied to the barge at the Azalea fleeting area (see figure 4).

**Figure 4.** *Cajole* partially submerged and secured to a barge after all involved personnel safely disembarked the vessel. (Source: Coast Guard)

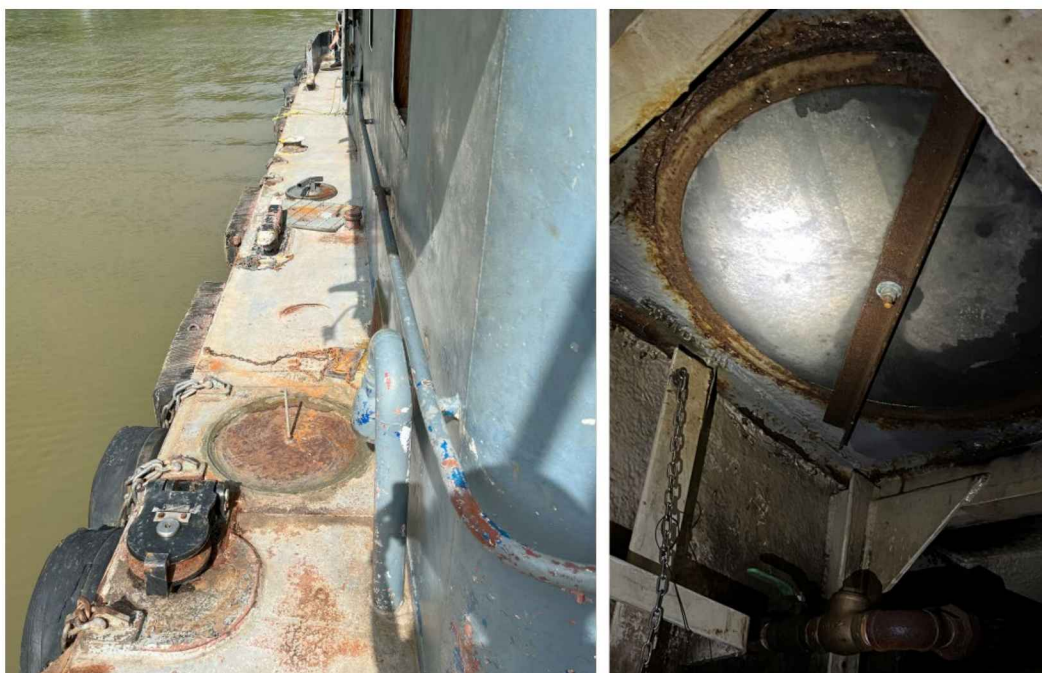
The sinking damaged the *Cajole's* main propulsion engines and generators, as well as its electrical and hydraulic systems beyond repair. Salvors made temporary repairs to keep the vessel afloat, including welding a replacement cover over the auxiliary space starboard-side flush-mounted hatch on the main deck to ensure watertight integrity as the vessel was towed to the shipyard for repair (see figure 5). (The hatch cover was lost during the casualty, but according to the captain, it was in place when he discovered the flooding in the engine room.)

**Figure 5.** *Cajole* after the sinking, with starboard side auxiliary void access hatch cover replaced and permanently sealed to the main deck for transit to shipyard.

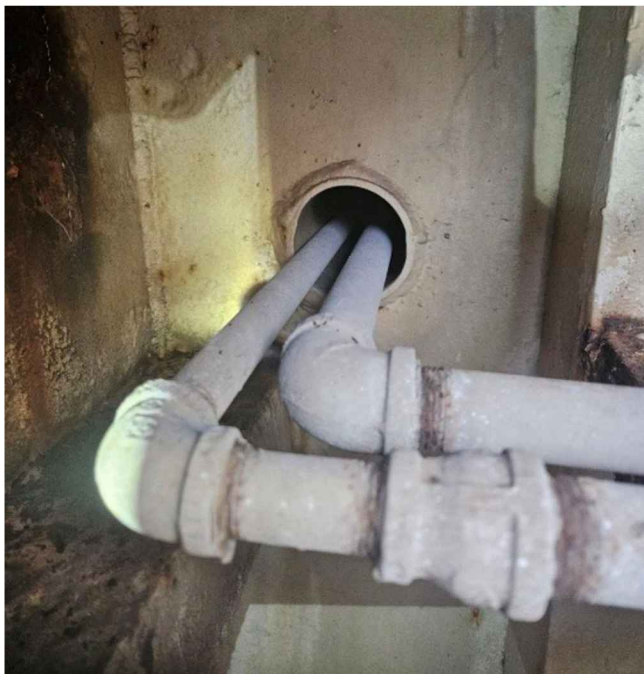
and electrical wire conduits between the forward auxiliary space and engine room that were not properly sealed and watertight (see figure 6). Company personnel sealed the piping and electrical wire conduits before the inspector's departure, and this was not recorded as a deficiency. The inspector told investigators that he received photos showing what he believed were the sealed conduits. He informed the operating company that the repairs were satisfactory. At that time, according to the inspector, the auxiliary space was sealed. No deficiencies were issued in this inspection, and the COI examination was scheduled for June 4, 2024.

**Figure 6.** View of unsealed conduit penetration between the engine room and auxiliary space from the auxiliary space on May 28, 2024. (Source: Coast Guard)

About 2 weeks before the casualty, a Coast Guard inspector found that piping and electrical wire conduits between the forward auxiliary space and engine room were not properly sealed to be watertight. Operating company personnel sealed the piping and electrical wire conduits, and the inspector signed off that the repairs were completed satisfactorily. However, based on the flooding that the captain saw coming through at least one of the conduits, the repairs the crew had made during the Coast Guard inspection were likely not completely effective. With the starboard-side conduit between the engine room and auxiliary void lacking watertight integrity, water was able to progressively flood between the spaces. Therefore, the water in the engine room was likely the result of progressive flooding, through the conduits, from

The National Transportation Safety Board determines that the probable cause of the flooding and sinking of the towing vessel *Cajole* was likely a compromised flush-mounted access hatch, which allowed water to flood into a forward void space, and unsealed penetrations in a transverse bulkhead, which allowed for progressive flooding aft into the engine room.

For the safety of a vessel and all on board, the integrity of the hull and watertight bulkheads must be maintained, and any deficiencies must be appropriately addressed. Issues with watertight integrity, including unsealed watertight bulkhead and deck penetrations and deck and hull plate wastage, need to be addressed by permanent means. The Coast Guard advises, "Ensure electrical cables and conduits, piping runs, remote valve actuators, and other components that penetrate watertight bulkheads, decks, and compartments are inspected frequently and properly maintained. Each may have a unique sealing method involving glands with packing assemblies, penetration seals, or other methods. Frequent inspection and proper maintenance of these various fittings and assemblies will assist in minimizing the possibility of progressive flooding."<sup>4</sup>
