MIR-25-46

## Sinking of *Barge PTC 706* and Subsequent Breakup of *Chad Pregracke* Tow

On March 16, 2024, about 0008 local time, the towing vessel *Chad Pregracke* was transiting southbound on the Lower Mississippi River pushing 34 loaded barges, near mile 260.6, about 5 miles east of New Roads, Louisiana, when a barge, the *PTC 706*, at the head of the tow rapidly sank, causing the tow to break apart (see figure 1 and figure 2).<sup>1</sup> Five barges in the tow were damaged. Damages were estimated at \$2 million. There were no injuries, and no pollution was reported.

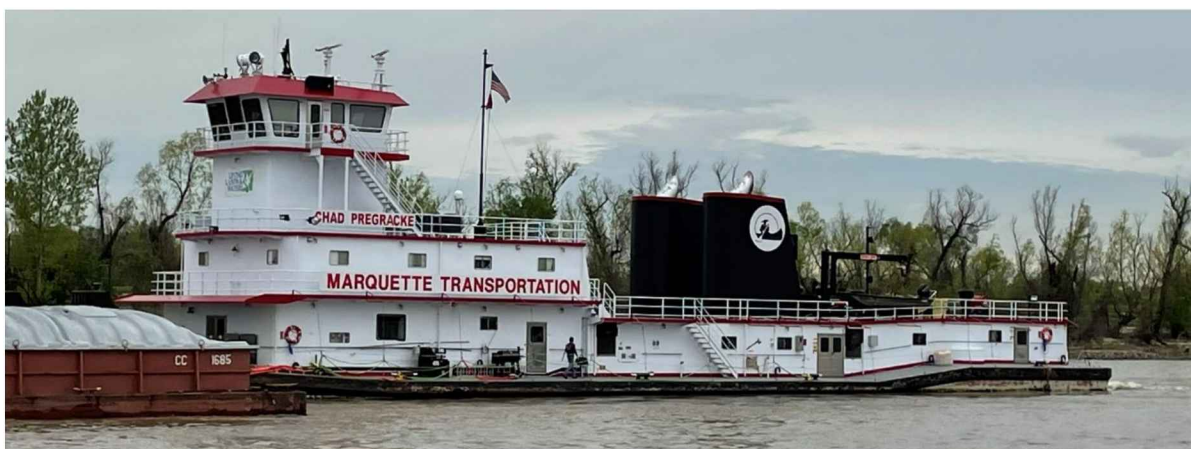
**Figure 1.** *Chad Pregracke* after the casualty.

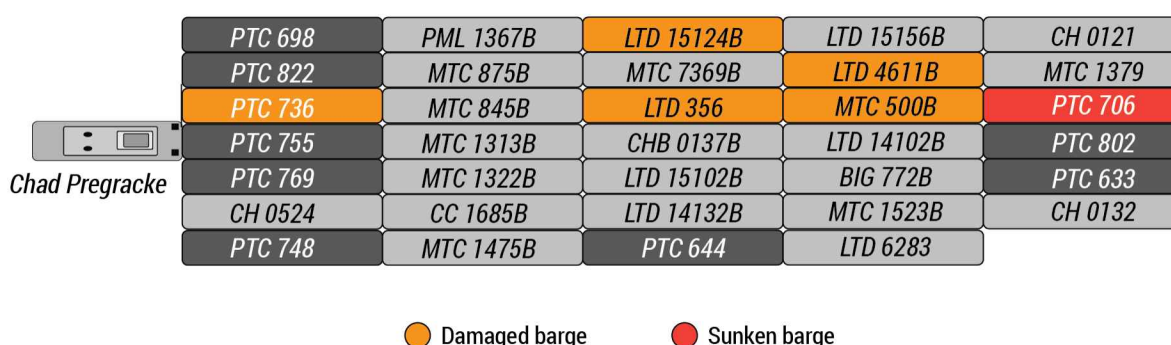
A marine survey company found damage to five barges, including flooding in various compartments, cargo loss and damage, and hull structure damage (see figure 5).

**Figure 5.** *Chad Pregracke* towing arrangement, showing the location of the damaged barges in orange and the sunken barge *PTC 706* in red.

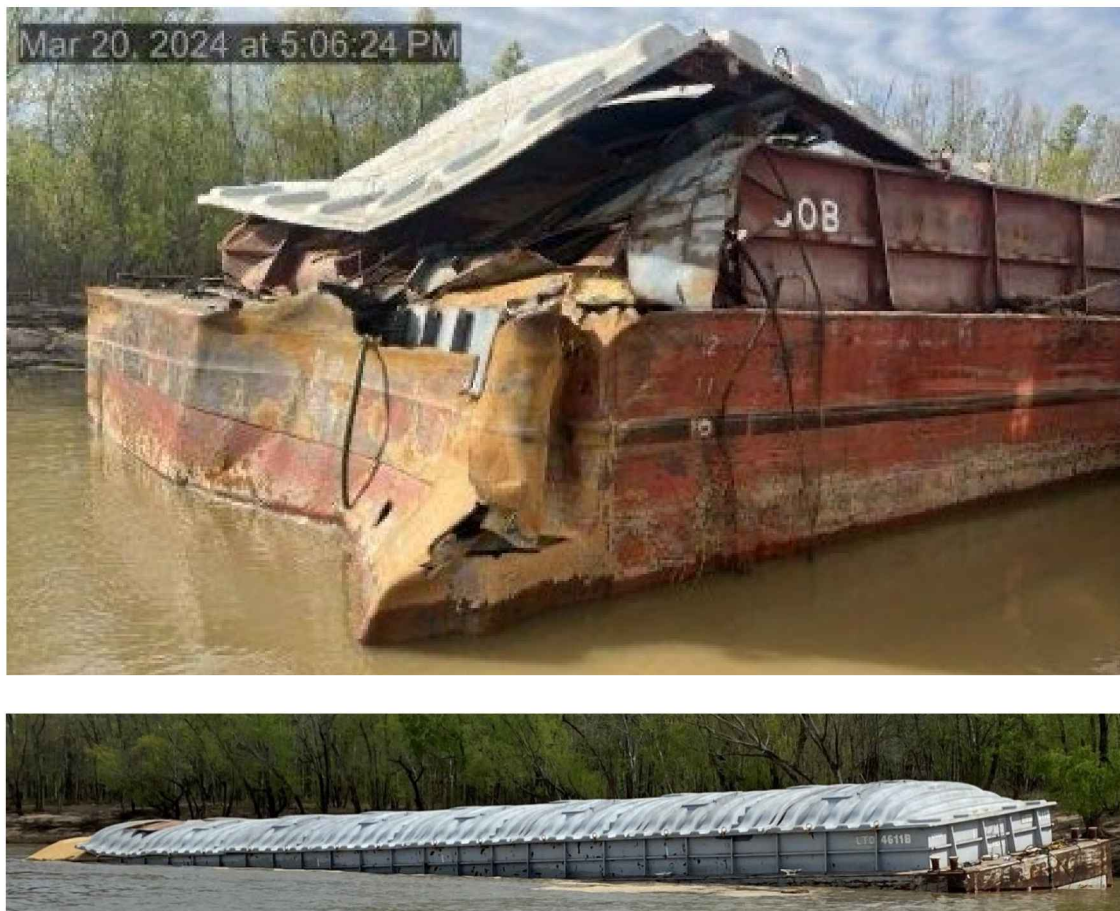
Of the damaged barges, three of them (*MTC 500B*, *LTD 356*, and *PTC 736*) were in the same string as the *PTC 706* (see figure 6). One of the other damaged barges (*LTD 4611B*) was located on the second string on the port side, second after the lead barge, and partially sank. The other damaged barge (*LTD 15124B*) was located on the outboard port string, third barge from the lead.

**Figure 6.** From top: Damage to the stern area of *MTC 500B*, the barge that was immediately aft of the *PTC 706*, and covered barge *LTD 4611B* partially sunken by its bow to port. (Source: Budwine and Associates, LLC)

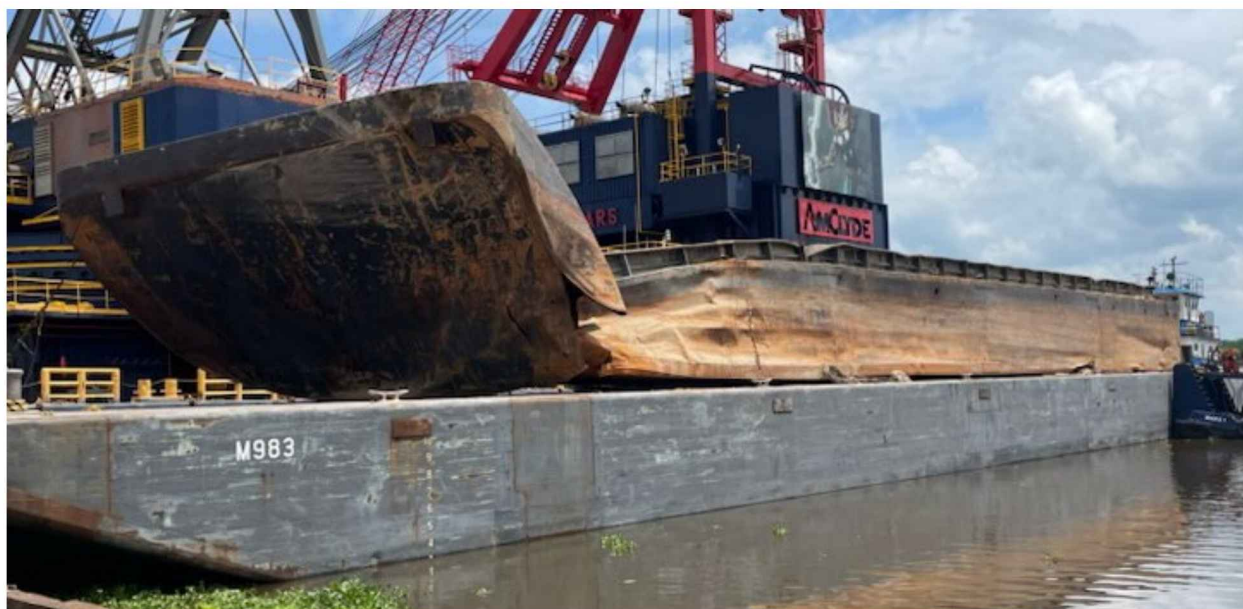
The *PTC 706* was a constructive total loss. Investigators examined the *PTC 706* at the recycling yard. The rake section was substantially damaged from contact with the river bottom (see figure 7). It was bent upward from near the watertight bulkhead between the rake void and the no. 1 wing tank. The port side of the barge in the vicinity of the watertight bulkhead between the rake void and the no. 1 wing tank exhibited substantial compressive forces and deformation to its plating.

**Figure 7.** Barge *PTC 706* after arriving at the recycling yard in Houma, Louisiana, on April 22, 2024, with damaged rake. (Source: Modern American Recycling Services, Inc.)

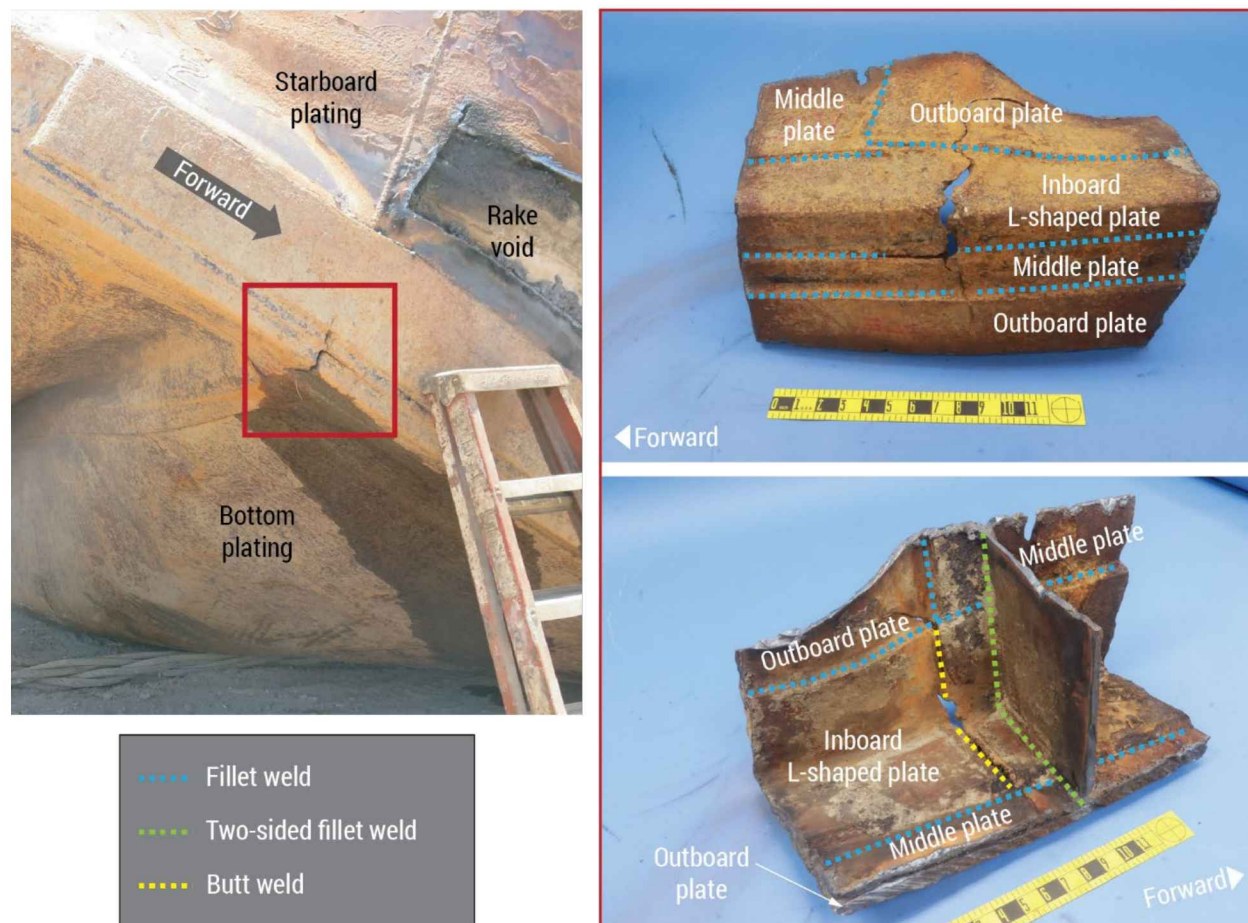
On the starboard side of *PTC 706*, at the bilge knuckle in the area between the rake void and wing tank no. 1, investigators found a hull fracture, dissimilar to any other damage observed.<sup>3</sup> This starboard side section of the bilge knuckle was cut out of the hull and sent to the National Transportation Safety Board (NTSB) Materials Laboratory for examination.

The NTSB found that the sectioned portion of the hull plating fractured initially along a 2.8-inch length of section of the vertical butt weld.<sup>4</sup> The butt weld exhibited a lack of penetration, with less than a third (0.162 inches) of the 0.5-inch plate thickness joined at the thinnest areas (see figure 8). This portion of the weld also exhibited large pores, some open to the surface, along with weld spatter and flash deposits in the welded areas between the plates.

**Figure 8.** Clockwise from left: *PTC 706* starboard-side bilge knuckle before section was cut away on April 22, 2024. Bilge knuckle section cutaway with labeling. Interior of the cutaway section.

After the casualty, investigators found a hull fracture along a butt weld forward on the starboard-side bilge knuckle of the barge, between the rake void and wing tank no. 1, an area susceptible to extreme wear. The weld exhibited a lack of weld penetration, with large pores, weld splatter, and flash deposits in the unwelded areas between the plates. These characteristics would have left the weld unable to accommodate as much load as the plates it was joining. Once the porous area of this butt weld fractured, the resulting crack would have grown into the adjoining plates until it arrested. If the fracture existed before the barge sank, it would have provided an opening for water ingress. Thus, flooding, even at a slow rate, into the rake void or wing tank no. 1, would cause an increase in forward draft of the barge. Continuing to push a barge with an increased forward draft could lead to the bow being submerged. However, the rake area of the barge was severely damaged as a result of the sinking, and investigators could not determine whether the fracture existed before the casualty or was the result of the barge's contact with the river bottom. Therefore, the cause of the *PTC 706* being down by the bow could not be definitively determined.
