**Transport Safety Investigation Bureau  
Safety Flyer – 2019/1**

**Use of appropriate fairleads for mooring**

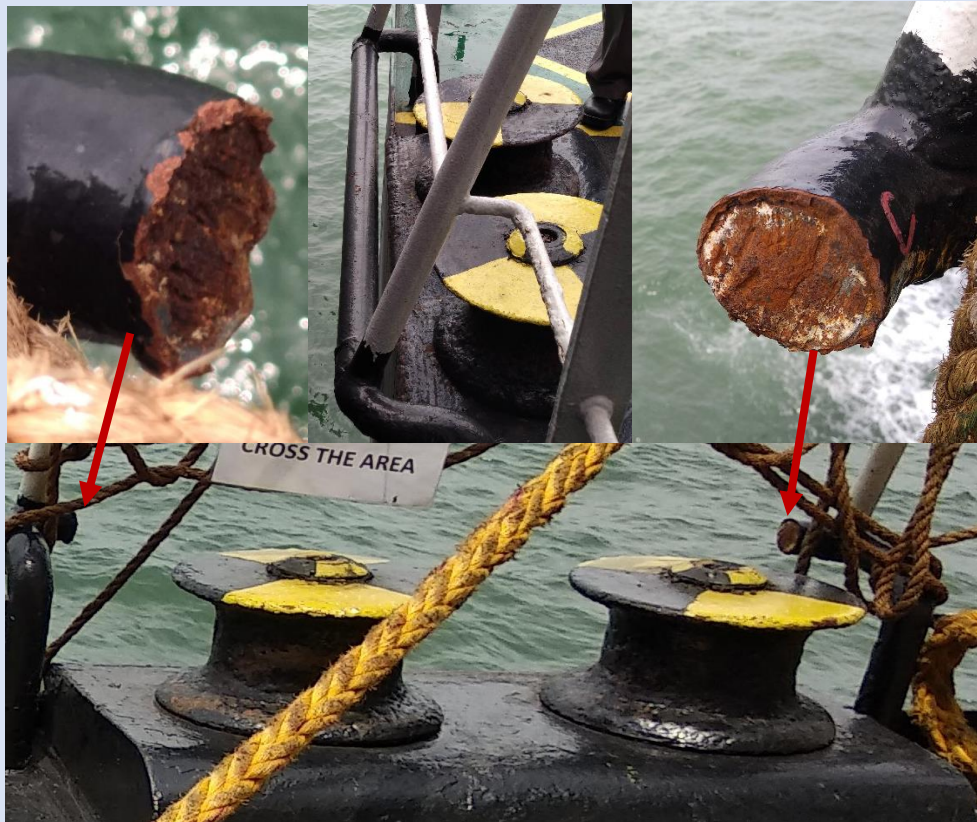
3. In a recent incident during bunkering operations when a bunker tanker was supplying bunkers to a container vessel at the berth, one of the bunker tanker's stern mooring rope jumped off (whiplash) from the open fairlead in an upward direction. This was due to the railing (referred to as a "stopper bar" by the ship and company), directly above the roller fairlead, breaking from the welded seams.

4. Closer inspection conducted on board the bunker tanker revealed some safety concerns -
  - a. The "stopper bar" was a part of the ship's railing and not a part of mooring fitting. (See **figure 1**)

Figure 1: The sheared off “stopper bar” above the roller fairleads

5. The company involved had changed all mooring fittings on the vessel to the universal type after the occurrence.

6. Mooring lines should only be led through closed fairleads (referred to as universal fairleads) suitable for STS operations. The use of stopper bars to retrofit open fairleads is not recommended as they are not designed or tested to withstand mooring loads.
7. Each ship should be provided with information on the design of the mooring system (including proper fittings/fairleads to be used for mooring) with examples to show the loads likely to be experienced under particular conditions and to illustrate those situations under which the limit of the system is likely to be reached.
8. Ship's crew should always be aware of the lead of the mooring lines that could be expected during the operation and highlight the hazards to the company so that appropriate risk mitigating measures can be implemented timely.

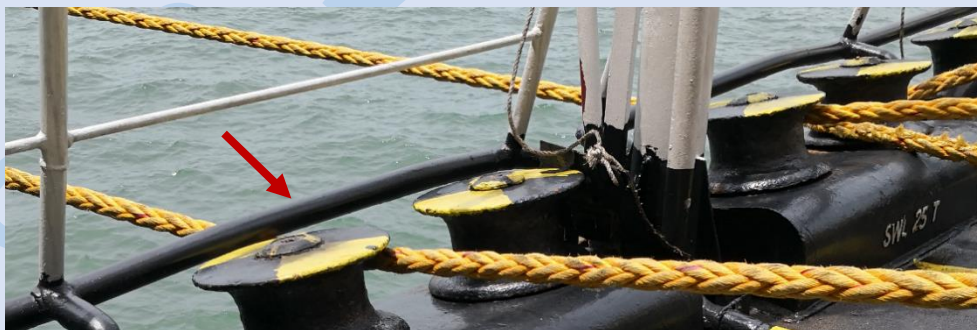
- b. There were no records to indicate the strength of this railing which was not designed or tested for mooring purpose. Over the period of the bunker tanker's operational life cycle, this railing had always been wrongly considered by the crew as a part of the mooring fitting during STS bunkering operations. The mooring lines usually had an upward lead and this had likely caused strain on the railing over time. (See **figure 2**)

Figure 2: Arrow showing the bent railing above the roller fairleads at the aft mooring station
