### SAFETY BULLETIN

SB01

MV NISYROS

## **OMAICO SAFETY BULLETIN Number 1**

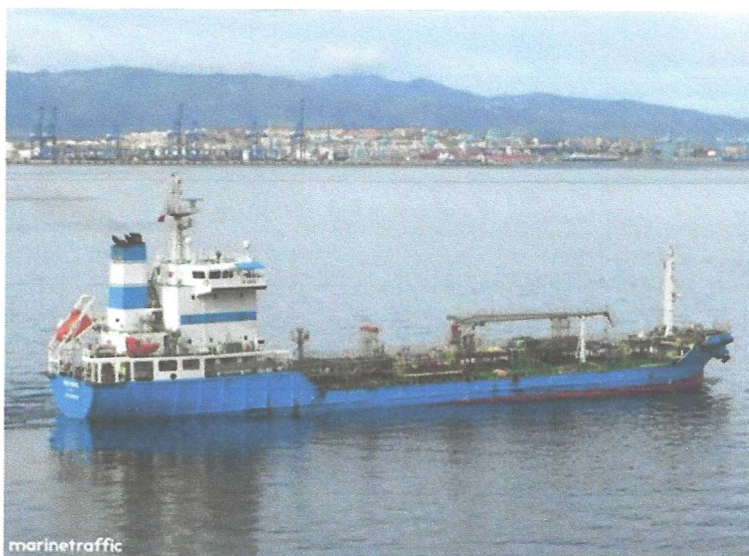
MV Nisyros is a Gibraltar registered tanker employed as a bunker barge in Gibraltar. The vessel was constructed between 2008 and 2010 and is of 4599GT. The number of seafarers employed on board exceeds the number required by the Safe Manning Document.
