MIR-25-46

## Sinking of *Barge PTC 706* and Subsequent Breakup of *Chad Pregracke* Tow

On March 16, 2024, about 0008 local time, the towing vessel *Chad Pregracke* was transiting southbound on the Lower Mississippi River pushing 34 loaded barges, near mile 260.6, about 5 miles east of New Roads, Louisiana, when a barge, the *PTC 706*, at the head of the tow rapidly sank, causing the tow to break apart (see figure 1 and figure 2).<sup>1</sup> Five barges in the tow were damaged. Damages were estimated at \$2 million. There were no injuries, and no pollution was reported.

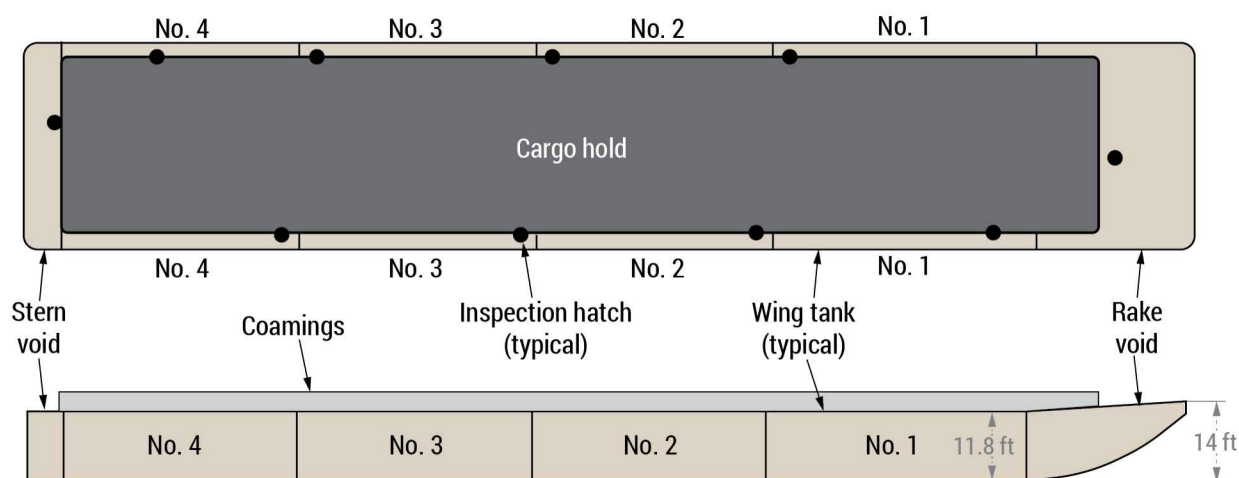
**Figure 3.** Simplified plan and profile views of hopper barge *PTC 706*.

The 200-foot-long *PTC 706* was a steel hopper barge built in 2012 and owned by Parker Towing Company. The hull depth of barge *PTC 706* was 11.8 feet. The raked bow of *PTC 706* sloped upward from the forwardmost watertight bulkhead between the rake void and wing tank no. 1 by 2.2 feet (see figure 3).<sup>2</sup> The coamings for the cargo hopper were 3 feet above the main deck. When the *Chad Pregracke* crew picked up the barge, along with other barges, on March 14, per company policy they recorded the *PTC 706*'s drafts on their load draft reading form at 9 feet 5 inches forward and 9 feet 6 inches aft.
